Streambank Remediation Study Final Report

**Conesus Lake Watershed
Livingston County Planning Department**

Stantec

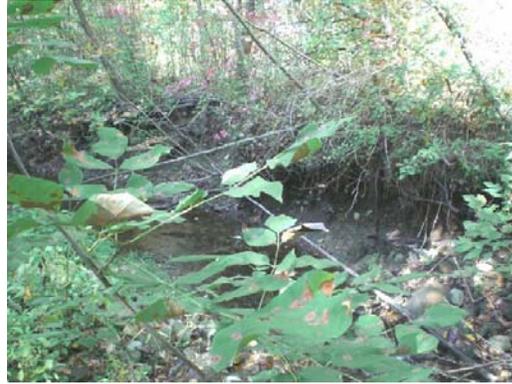
Photo 4 –Bank erosion and migration

The upper middle reach of Densmore Creek has moderate sediment loading. The bank migration will continue on the left bank and increase chance for hillslope erosion and possible failure of the subgrade and berm of Cleary Road. The major source of eroded sediment from the bank migration is at low production rate and limited to a 400 ft section of stream.

This reach should be observed with bank erosion pins over the next couple of years to assess the risk of roadway damage due bank erosion. Bank erosion pins allow for measurement of the annual bank migration rate. If the bank migration rate is at a rate that will risk the integrity of Cleary Road, then the channel should be relocated or structures should be installed to protect the bank from erosion and accelerated bank migration.

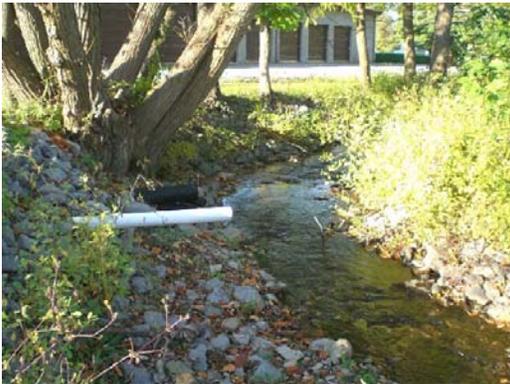
Photo 7 – Rip Rap protection active drains

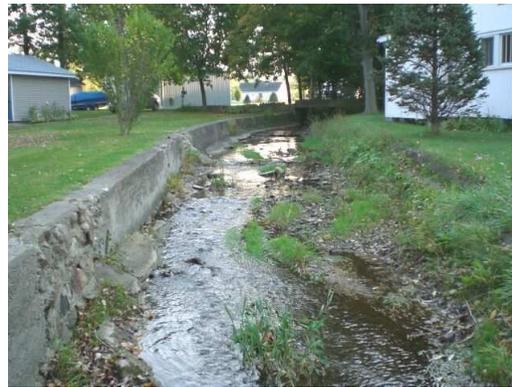
Photo 10 – Concrete Retaining wall

In the lower reach of Densmore the channel is straightened and levied, but the channel still has access to a floodplain for large flows. The channel is also wide enough to spread out the flow and limit the shear stress that causes erosion. This reach will continue to build lateral sediment bars.

When retaining walls are repaired or rebuilt they should be constructed to a height of no greater than the natural floodplain elevation.

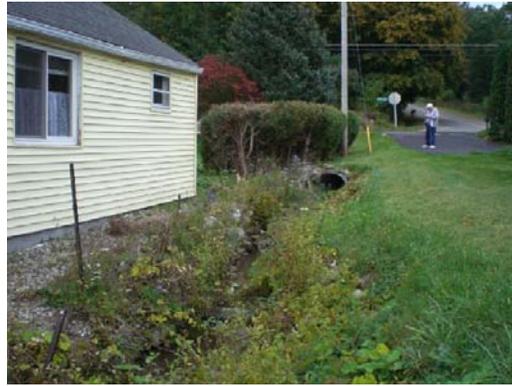
Photo 6- Poor riparian buffer

The lower reach of Central Creel will continue to degrade and there will be bank erosion and possible bank migration on the right bank. The bank migration rate will be limited since the reach is flat. The foundation of the residential dwelling on the right bank is currently at risk of being undermined. The left bank is higher than the right bank and directs flooding to the right overbank area.

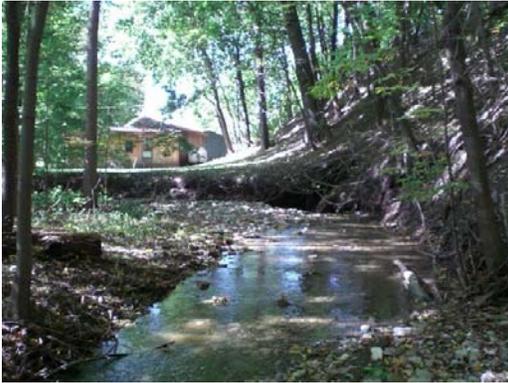
Photo 3 - Property loss residential yard

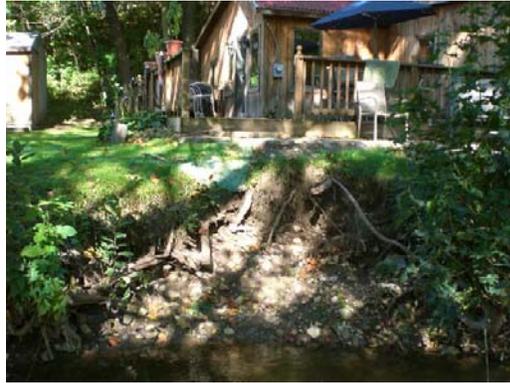
Photo 4 - Property loss foundation failure

The middle reach will continue to be laterally unstable until the floodplain has reached a stable form. The water and sediment supply of the watershed will dictate the stable form of the stream channel. The current bank migration and bank erosion will continue to add to the sediment supply of this reach of North Gully. The foundation of the residential dwelling will be undermined and the land loss will continue until the right bank is stabilized.

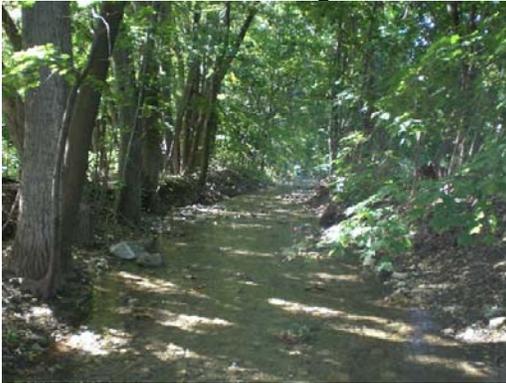
Photo 5 – Left bank failing levee

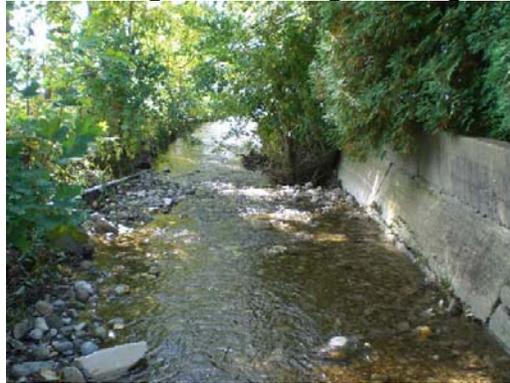
Photo 6- Right bank failing retaining wall

The lower reach of North Gully will continue to flood and dredging will be required to continue drainage until the sediment in the watershed is stabilized. The right bank erosion will progress leading to possible failure of retaining walls and structures. The levees will assist in increasing the forces for sediment transport but as more sediment is transported downstream more sediment will accumulate behind the undersized culvert.

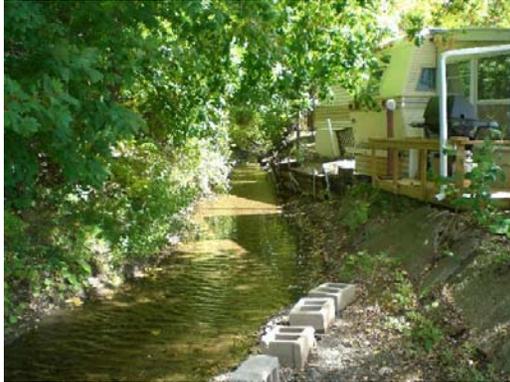
Photo 5 – Left bank failing retaining wall

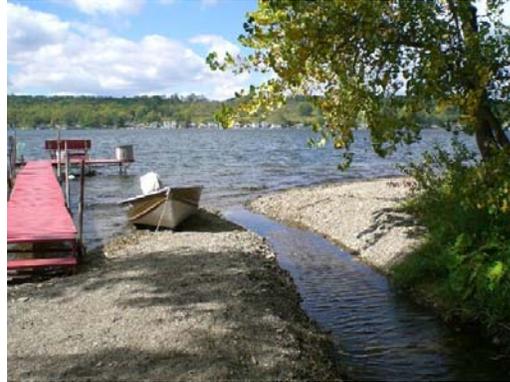
Photo 5- Sediment fan & Conesus Lake

The lower reach of South Gully will continue to flood and the sediment fan will continue to control the water surface elevation of the creek, unless the sediment source upstream is reduced. The left bank erosion and possible failure of retaining walls and structures will progress unless flow is deflected from the banks and the bank is vegetated and/or armored.

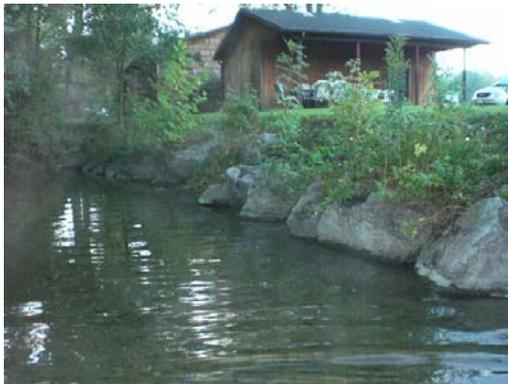
Photo 5 - Left bank boulder toe protection

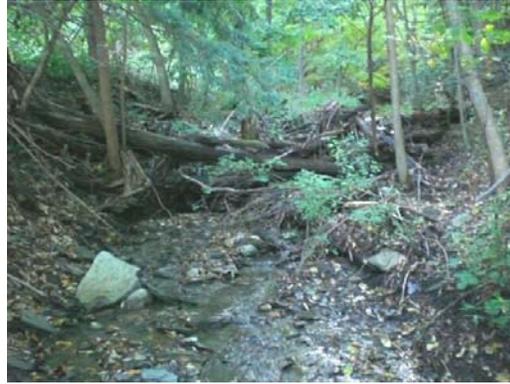
Photo 4- Sediment debris dam

The lower reach will continue to be unstable until the floodplain has reached a stable form. The lower reach is serving as sediment sink with the sediment deposition occurring on the bars and benches to fill in the over wide channel. Currently the sediment supply on this reach is from upstream bank erosion. The water and sediment supply of the watershed will dictate the stable form of the stream channel. The lower sediment debris dam is within 150 ft of West Lake Road. A major dam break would cause debris to flow downstream and jam the roadway culvert. If the roadway culvert is jammed the roadway would be overtopped and risk of roadway failure would be increased.

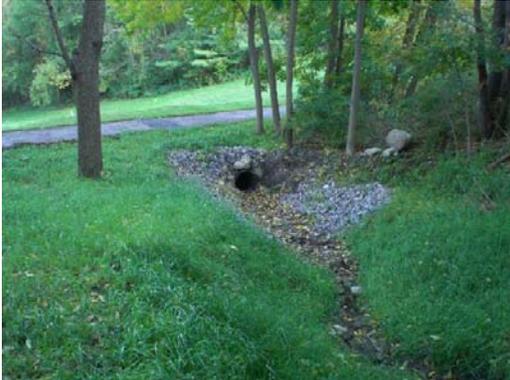
Photo 5 – Culvert under driveway & rip rap

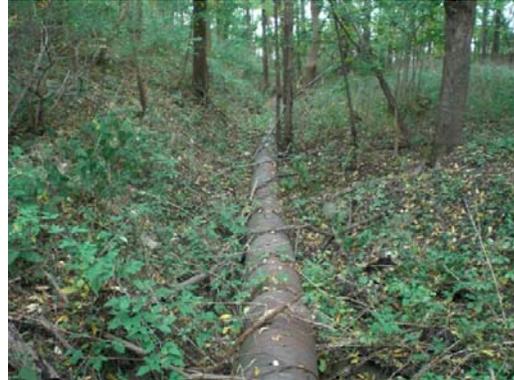
Photo 6 – Exposed and failing pipe

The lower middle reach will continue to be unstable with the exposed pipe deflecting and constricting flow. There is a stable floodplain but the channel will not be able to stabilize without the removal of the drainage pipe. The landowners yard will collapse into a new stream channel as the material is eroded downstream.

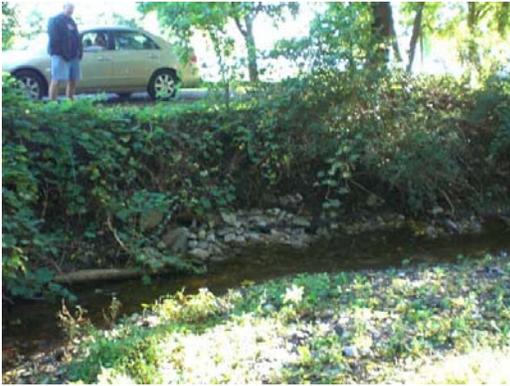
Photo 5 – Driveway and bank erosion

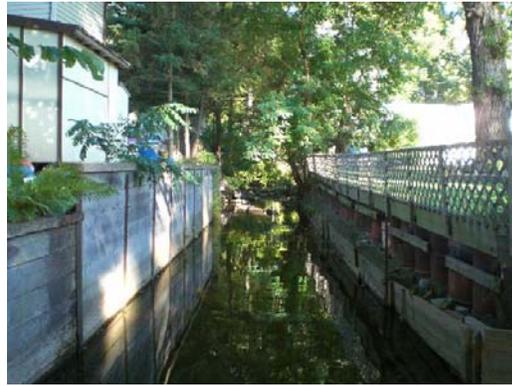
Photo 6- Retaining walls and levees

The lower reach of Long Point will continue to cut away at both banks in the upper 900ft of the free flowing section of this reach. The channel will continue to meander. The natural stable form and pattern of Long Point Creek would be a sinuous channel with a dimension of nearly 30 ft². In the lower reach of Long Point Creek the channel is straightened and leved and therefore has no access to a floodplain for large flows. The result will be continued bank erosion as the channel carves a stable pattern and new floodplain. The foundation of the residential dwelling will be undermined, the driveway on the left bank will slump into the stream and the land loss will continue until the left bank is stabilized. The right bank erosion and possible failure of retaining walls and structures will also progress. Levees will increase the shear forces causing bank erosion and scour, increasing the propensity of stagnant water.

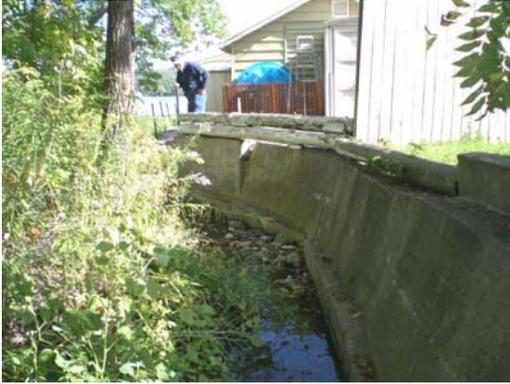
Photo 7 – Failing Concrete Retaining walls

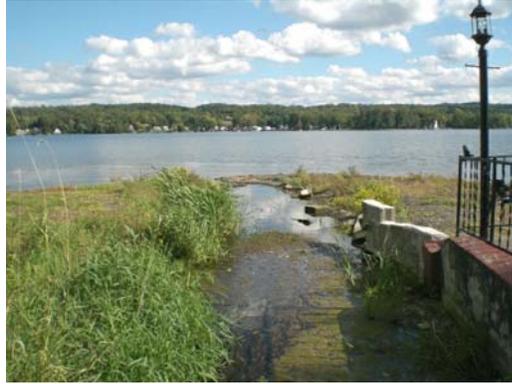
Photo 8- Sediment Fan Conesus Lake

The lower reach of Sand Point will continue to cut away at both banks in the upper, free flowing section of the reach. The channel will continue to meander. The natural stable form and pattern of Sand Point Creek would be a sinuous channel with a dimension of near 30 ft². In the lower reach of Sand Point the channel does not have access to the floodplain during large flows as it has been straightened and levied. The foundation of the residential dwelling will be undermined and land loss will continue until the left bank is stabilized. The right bank erosion and possible failure of retaining walls and structures will also progress. Levees will increase the shear forces causing bank erosion and scour, increasing the propensity of stagnant water.

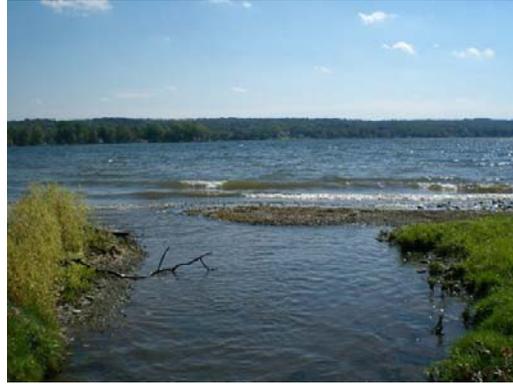
Photo 8- Sediment fan Conesus Lake

The lower reach of Eagle Point will continue to aggrade in the upper, free flowing section of this reach. The channel will continue to meander. The natural stable form and pattern of Eagle Point Creek would be a sinuous channel with a dimension of nearly 30 ft². In the lower reach of Eagle Point the channel is straightened and levied, resulting in the channel not having access to a floodplain for large flows. The foundations of the residential dwellings are not currently at risk of being undermined while this reach continues to be in a state of aggradation. There are three stream crossing and culverts on this section that hold grade and back up water during high flows.
