March 6, 2018  
Revised August 3, 2018

Re: Analysis of Recommended Short-term Streambank Stabilization Options  
North McMillan Creek - Town of Conesus

File: 338.007.001

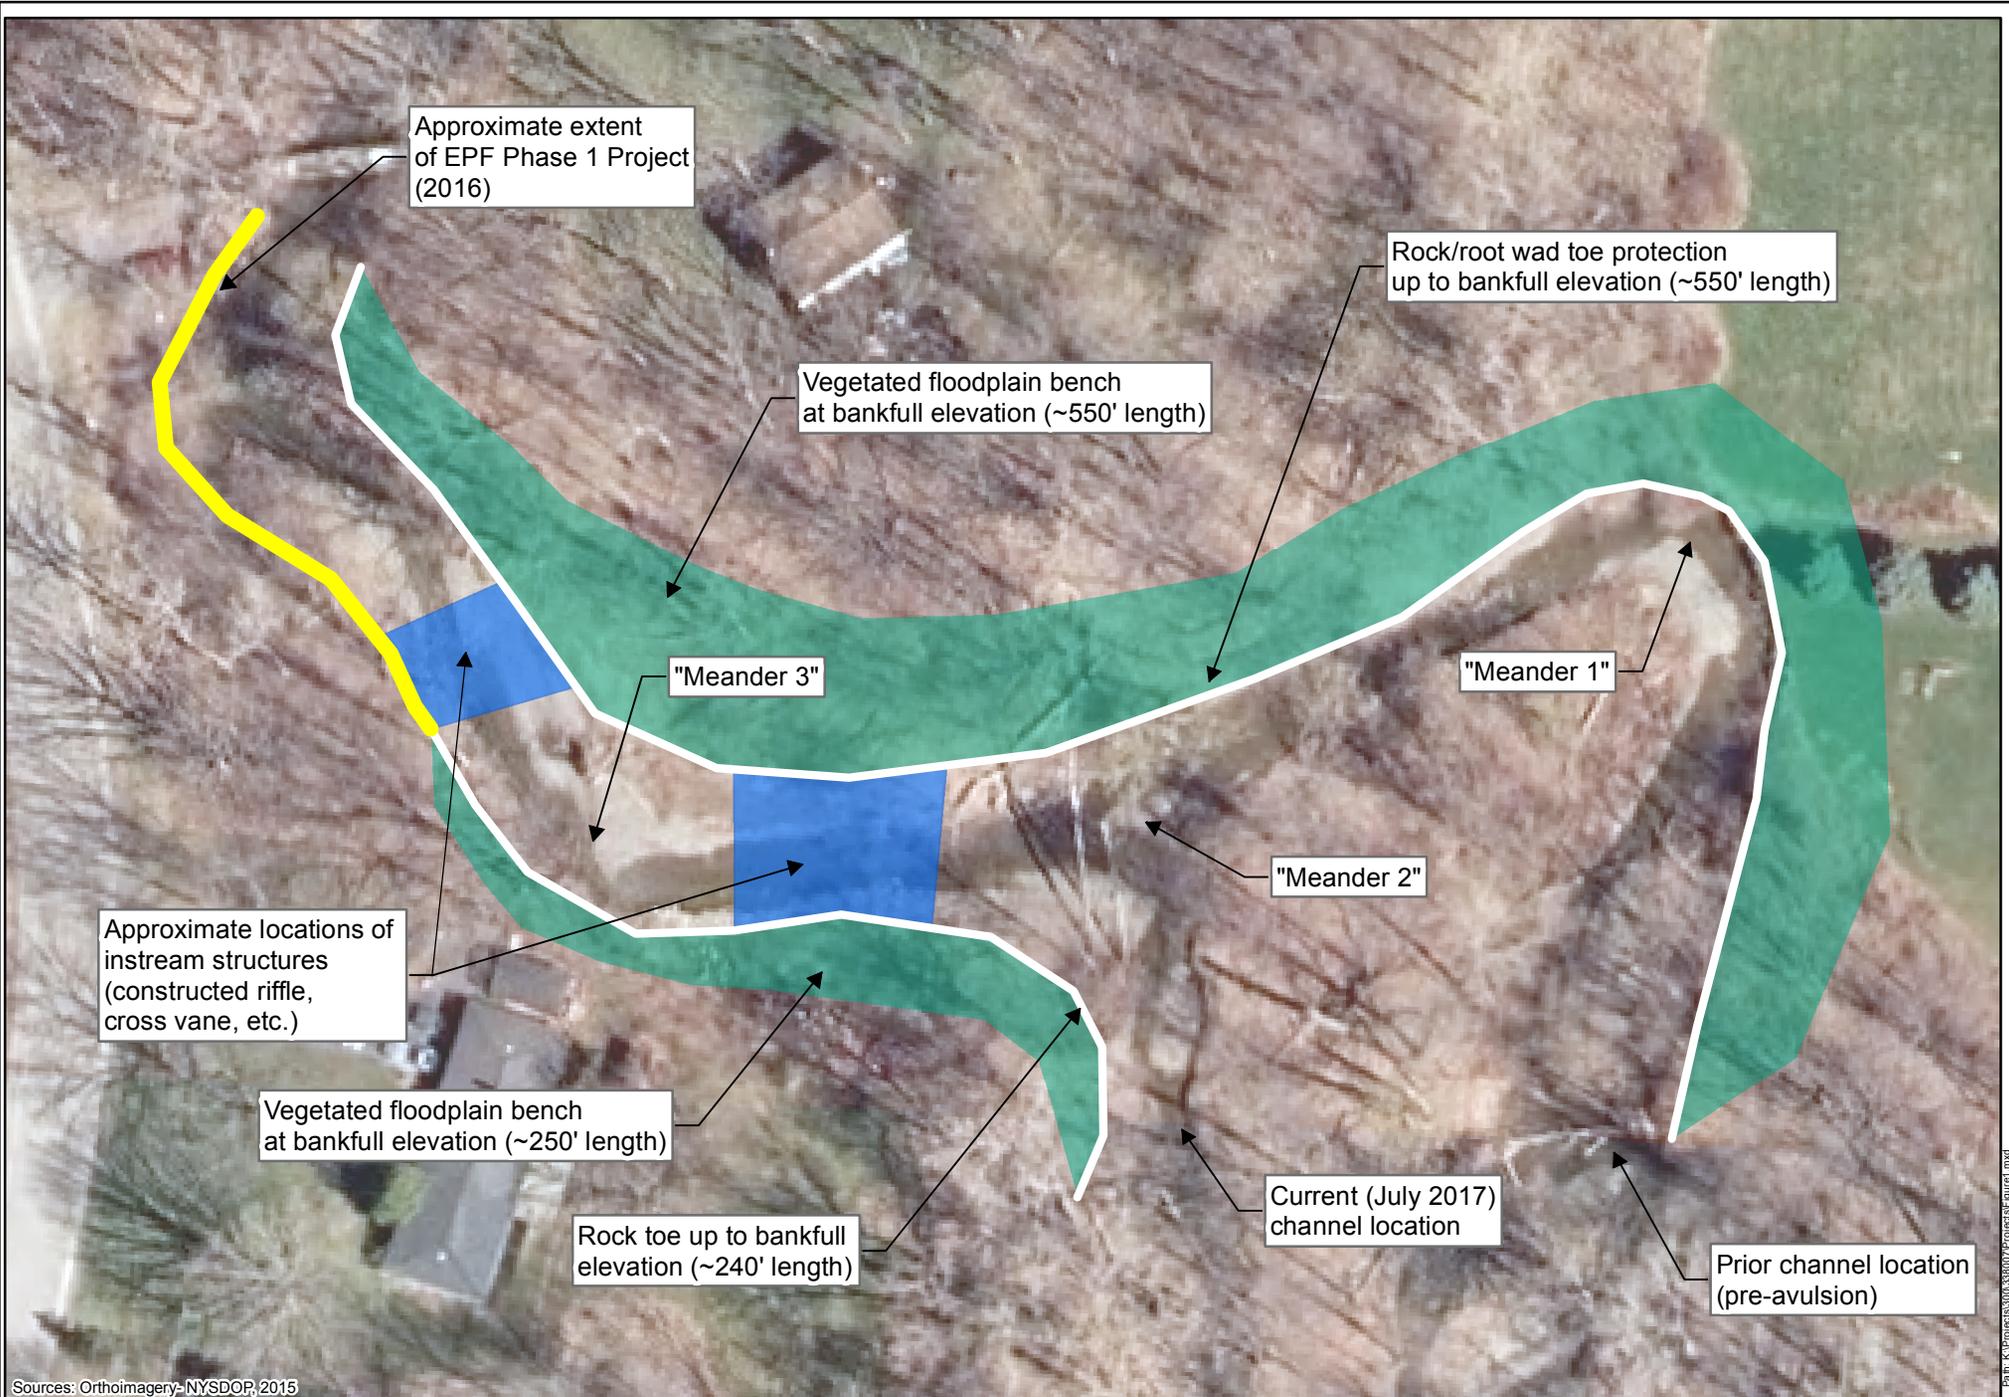
- Within the last year, the upstream portion of ROI has relocated (through avulsion of an adjacent paleochannel) to an alignment approximately 125 feet west of its previous position, abandoning a portion of the former channel adjacent to the Marino property (see “Meander 1” on Figure 1).

- The avulsion of the channel as described above has significantly reduced radius of curvature adjacent to the Koch and Parsons/Garbacik properties (see “Meander 2” and “Meander 3” on Figure 1). As a result, near-bank stress and erosion potential are significantly elevated due to the abrupt curvature of the stream in these locations. Streambanks are much more prone to failure, particularly as a result of fluvial entrainment of the bank toe (undermining).

- *Meander #1:*
  - Erosional surface: 285 linear feet x ~3.1 feet bank height (average) = 883.5 square feet
  - BEHI rating\*: High
  - NBS rating\*: Low
  - Estimated Sediment Yield: =0.46 ft/yr. x 883.5 square feet = 406.5 cubic feet (21 tons) annually
  - Erosion reduction\*\*: 90%
  - Estimated Sediment Yield Reduction: 18.9 tons/yr

- *Meander #2:*
  - Erosional surface: 105 linear feet x ~2.8 feet height (average) = 294 square feet
  - BEHI rating\*: High
  - NBS rating\*: Very High
  - Estimated Sediment Yield: 1.7 ft/yr x 294 square feet = 499.8 cubic ft (27 tons) annually
  - Erosion reduction\*\*: 90%
  - Estimated Sediment Yield Reduction: 24.3 tons/yr

- *Meander #3:*
  - Erosional surface: 170 linear feet x ~3.3 feet height (average) = 561 square feet
  - BEHI rating\*: Very High
  - NBS rating\*: High
  - Estimated Sediment Yield: 1.2 ft/yr x 561 square feet = 673 cubic ft (36.4 tons) annually
  - Erosion reduction\*\*: 90%
  - Estimated Sediment Yield Reduction: 32.7 tons/yr

- Install approximately 240 linear feet of rock toe along the left bank of North McMillan Creek, extending upstream from the upper end of the EPF Phase I project. Rock toe should be constructed at an elevation that allows engagement of a constructed floodplain bench behind the revetment along the left bank (see item #4 below). Rock toe should be positioned outward from the existing bank line to reduce the existing curvature of the stream at the location of the Parson's shed. It is also important to maintain appropriate curvature through the entirety of the segment, including a transition to the left bank of the now-existing upstream (avulsed) channel. Manipulation of the stream channel to appropriate dimensions, slope, and planform to accommodate this placement of rock toe should be professionally-engineered to ensure competent flood and sediment conveyance, as well as to maximize longevity of the structural elements of the work. Realignment of the channel without consideration to these aspects will not only minimize longevity of the project, but can exacerbate stream instability issues downstream, including the EPF Phase I project.

- Construct approximately 250 feet of floodplain bench along the left bank of North McMillan Creek at the location shown on Figure 1. The bench should be constructed at the bankfull elevation, providing for a section of nearly-flat ground extending from the top of the revetment back to the toe of the existing eroded streambank. The width of the bench would be dependent on final channel alignment and configuration of the rock toe and existing streambank. The bench would be constructed with fill, stabilized, and vegetated. A floodplain bench allows for increased flood conveyance, which reduces both flood elevation and velocity. Roughness provided by vegetation on the top of the bench reduces near-bank stress and increases resistance to erosion.

- Grade streambank along approximately 550 feet of the right bank on Koch/Marino properties to establish floodplain bench (see Figure 1). This would incorporate treatments to "Meander 1" and "Meander 2". Protect the bank toe with combined root wad/boulder clusters. Root wads could likely be sourced from trees removed to accommodate floodplain grading on both sides of the stream.

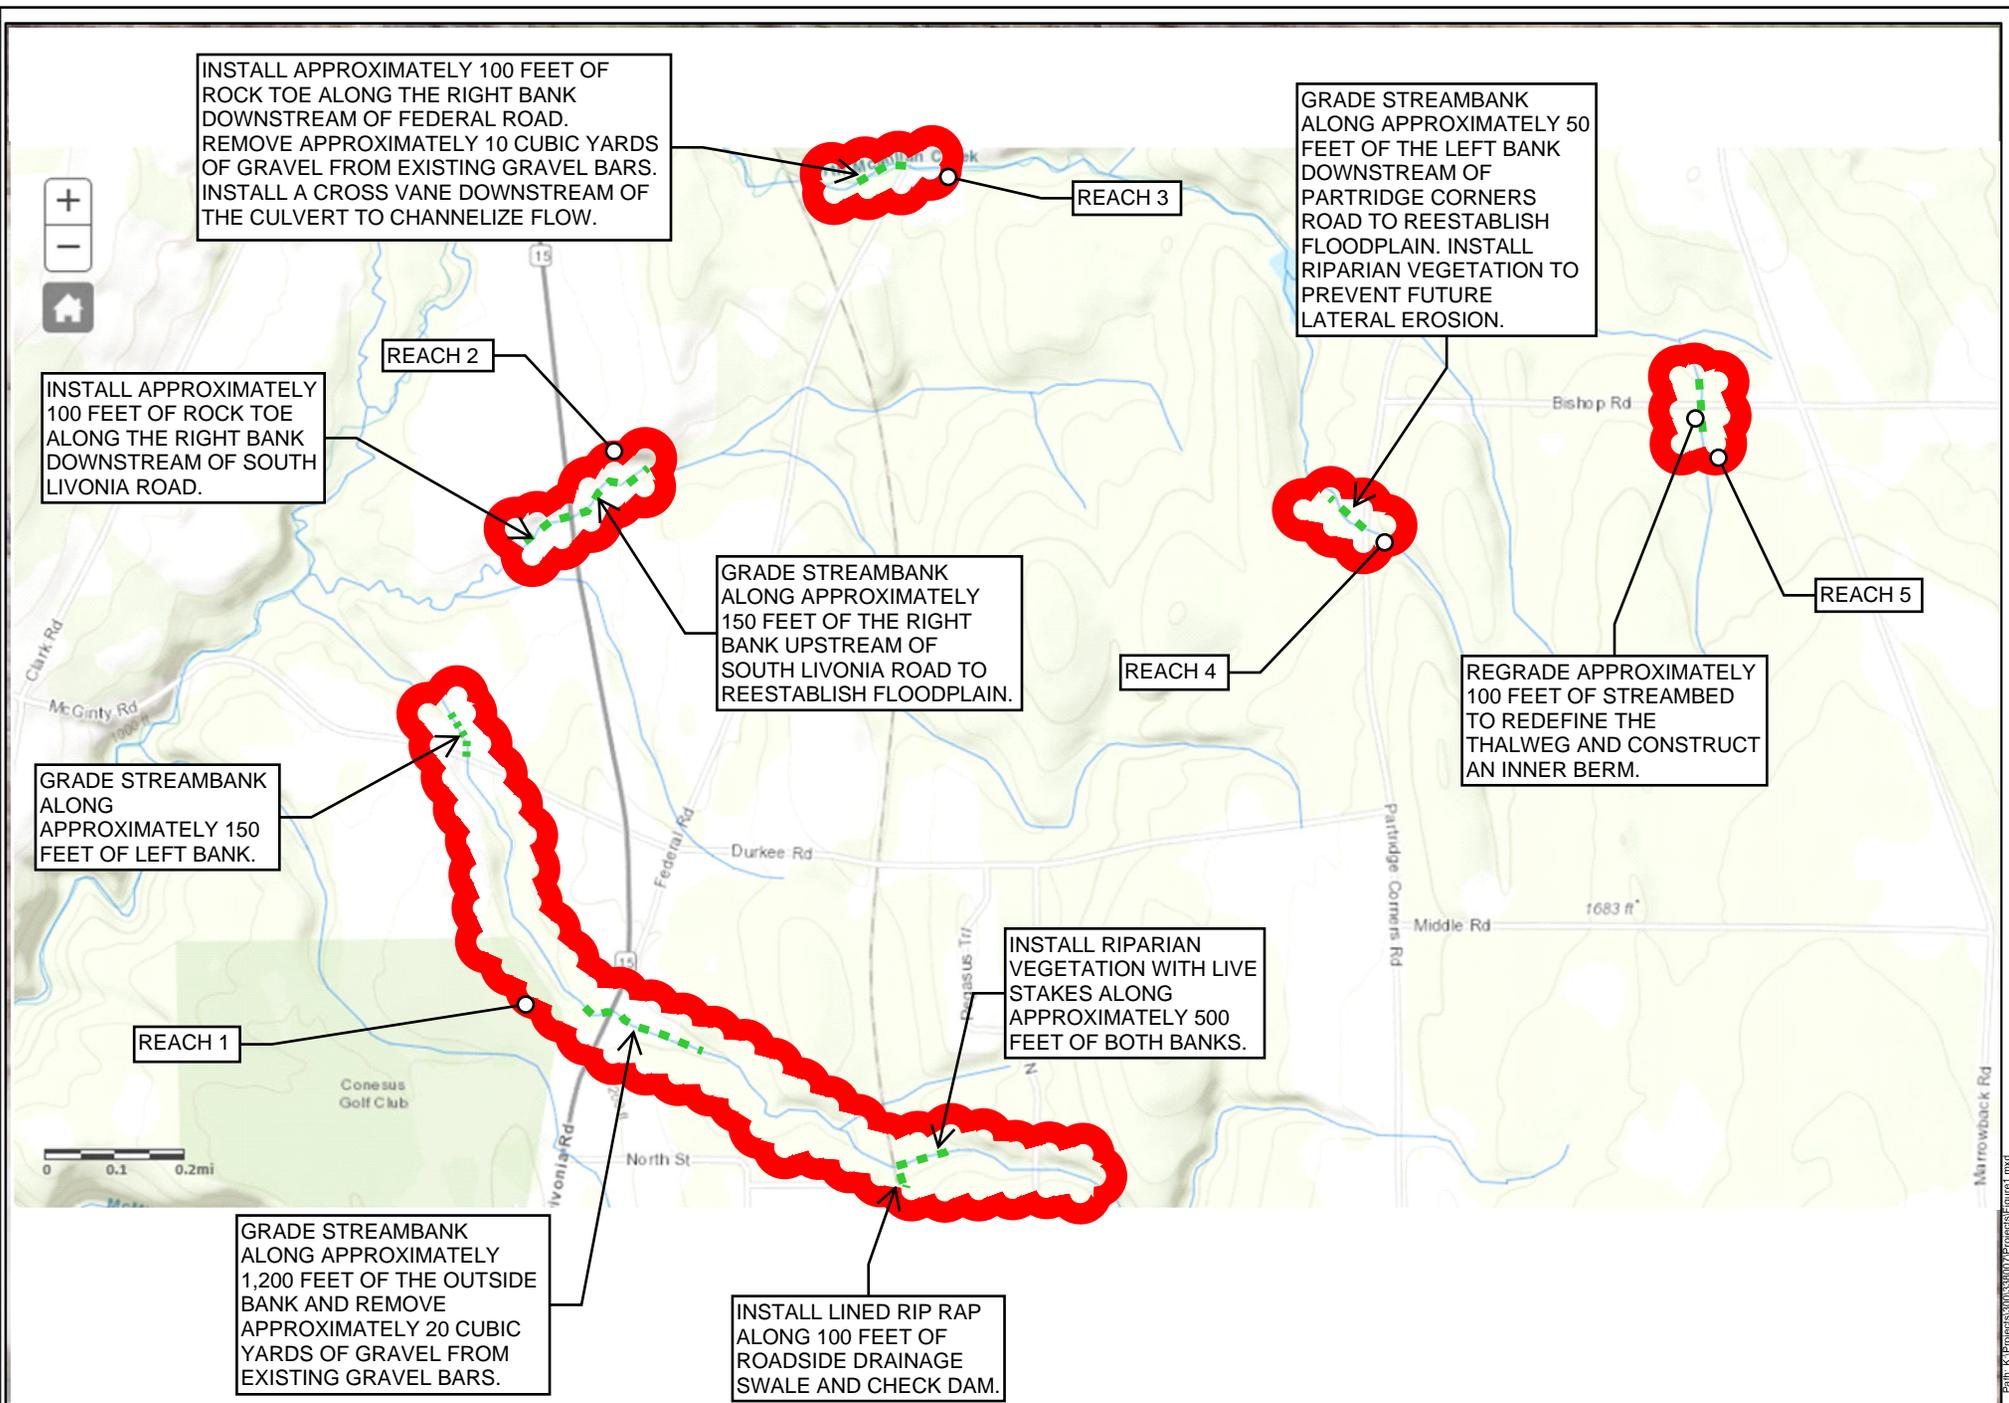
- Reach 1, located between McGinty Road and North Railroad Avenue exhibits severely poor riparian vegetation along banks that induce lateral erosion during higher storm events. A large area of erosion and poor riparian vegetation growth was observed just upstream of the North Railroad Avenue crossing. Gravel bars were observed downstream near Federal Road, causing

- Reach 2, located under South Livonia Road, exhibits atypically lower width to depth ratio due to its confined nature. Severe bank erosion on the downstream end of the culvert under South Livonia Road may be attributed to the high degree of confinement directly upstream. The lack of a floodplain allows no velocity dissipation. Lateral confinement may be attributed to an access road on the southern end and farm activities on the northern end, both on the east side of South Livonia Road.

- Reach 3, located under Federal Road, exhibits lateral scouring of the banks. Scouring is eroding private property and creating a large scour pool just downstream of the culvert as excessive flows exit the culvert.

- Reach 4, located under Partridge Corners Road, is farther upstream and conveys less flow being a first order stream. However, upstream of the culvert under the road exhibits a confined channel with no established floodplain. Downstream of the culvert, lateral scouring is eroding private property that is most likely attributed to a large meander directly downstream of the confined channel. A roadside swale, lined with rip rap in one section, exhibits high to severe bank erosion where rip rap is not present. This swale drains directly into Wilkins Creek at the Reach 4 location.

- Grade streambank along approximately 150 feet of the left bank downstream of McGinty Road along Reach 1 to reestablish the flood plain and have a consistent width-depth ratio with the reach directly upstream. Live stakes should be planted along the bank to assure stability given the outside meander.

- Grade streambank along approximately 1,200 feet of the outside bank near South Livonia Road along Reach 1 to reestablish the flood plain. Additionally, remove approximately 20 cubic yards of gravel from existing gravel bars to minimize future potential for lateral scour.

- Install riparian vegetation with live stakes along approximately 500 feet of both banks along Reach 1 just upstream of North Railroad Avenue. The vegetation should extend 20 feet upslope from the stream. Additionally, install lined rip rap along 100 feet of a roadside drainage swale and a check dam prior to the stream confluence.

- Install approximately 100 feet of rock toe along the right bank within Reach 2 downstream of South Livonia Road. Rock toe should be constructed at an elevation that allows engagement of a constructed floodplain bench behind the revetment along the left. Rock toe should be positioned outward from the existing bank line to reduce the existing curvature of the stream. It is also important to maintain appropriate curvature through the entirety of the segment. Manipulation of the stream channel to appropriate dimensions, slope, and planform to accommodate this placement of rock toe should be professionally-engineered to ensure competent flood and sediment conveyance, as well as to maximize longevity of the structural elements of the work. Realignment of the channel without consideration to these aspects will not only minimize longevity of the project, but can exacerbate stream instability issues downstream.

- Grade streambank along approximately 150 feet of the right bank upstream of South Livonia Road along Reach 2 to reestablish the flood plain. This section is uncharacteristically confined and should be regraded to allow a larger width-depth ratio.

- Install approximately 100 feet of rock toe along the right bank within Reach 3 downstream of Federal Road. Remove approximately 10 cubic yards of gravel from existing gravel bars to minimize future potential for lateral scour. Additionally, install a cross vane downstream of the culvert to channelize flow and minimize potential for gravel bar formation.

- Grade streambank along approximately 50 feet of the left bank downstream of Partridge Corners Road within Reach 4 to reestablish the floodplain. Install riparian vegetation to prevent future lateral erosion.
