SYNOPTIC WATERSHED SURVEY
Conesus Lake Watershed
May 26, 2000

**Purpose of the Survey: Assess the Status of the Streams Macroinvertebrates and
Evaluate the Condition of Major Tributaries**

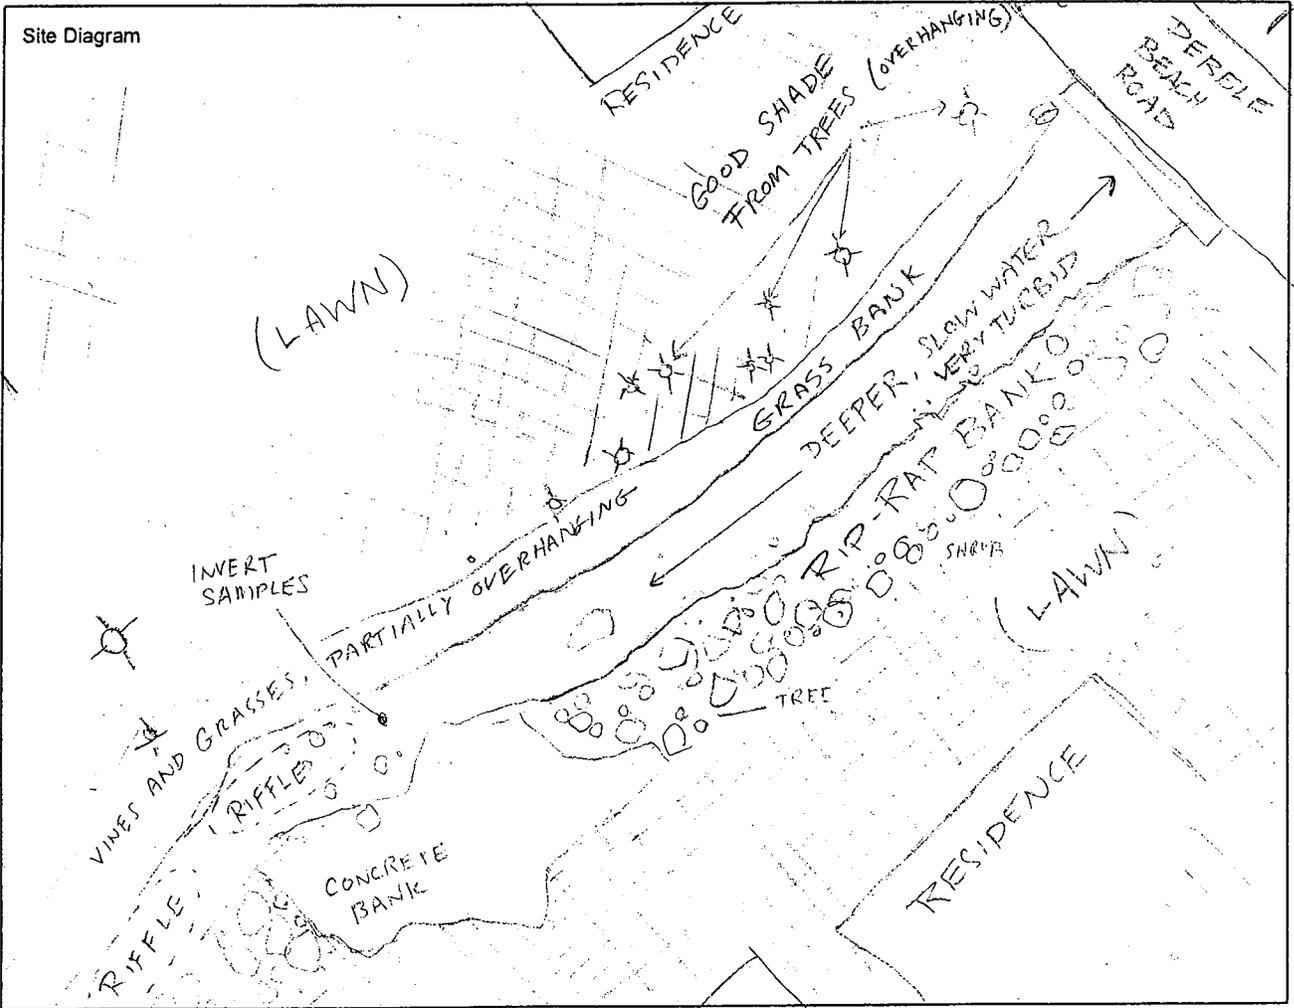
Owners name _____ Evaluator's name _____ Date 5/17/10
 Stream name HAWKAS CREEK Waterbody ID number 7
 Reach location JUST WEST OF PEBBLE BEACH RD CROSSING
 Ecoregion _____ Drainage area _____ Gradient _____
 Applicable reference site _____
 Land use within drainage (%): row crop _____ hayland _____ grazing/pasture _____ forest _____ residential _____
 confined animal feeding operations _____ Cons. Reserve _____ industrial _____ Other: _____
 Weather conditions-today Sunny Past 2-5 days 2" rain 3 days ago
 Active channel width 5 FEET Dominant substrate: boulder 10% gravel 10% sand _____ silt _____ mud _____
COBBLE 40%

Suspected causes of observed problems RIP-RAP EMBANKMENT AND CONCRETE-LINED BANK REDUCE SUITABLE HABITAT. LAWNS ON EITHER SIDE ALSO ENCRDACH ON RIPARIAN CORRIDOR, REDUCING SHADE AND HABITAT. SIGNIFICANT UPSTREAM IMPACTS RESULT FROM D.O.T. STATION, ROADS, AND DEVELOPMENT.

Recommendations REPLACE RIP-RAP WITH MORE VARIED- AND VEGETATED EMBANKMENT. RECOMMEND SET-BACK OF LAWNS AND RESIDENTIAL ACTIVITY FROM STREAM. INVESTIGATE UPSTREAM NUTRIENT INPUTS FROM SOURCES MENTIONED ABOVE.
