Stream Visual Assessment Protocol
Visual Assessment Score (VAS)
Natural Resource Conservation Service

Observed Problems and Recommended Solutions Regarding Tributaries of Conesus Lake
 May 16-17, 2000

Tributary Characterization for Conesus Lake, May 16-17, 2000
 Visual Assessment Scores

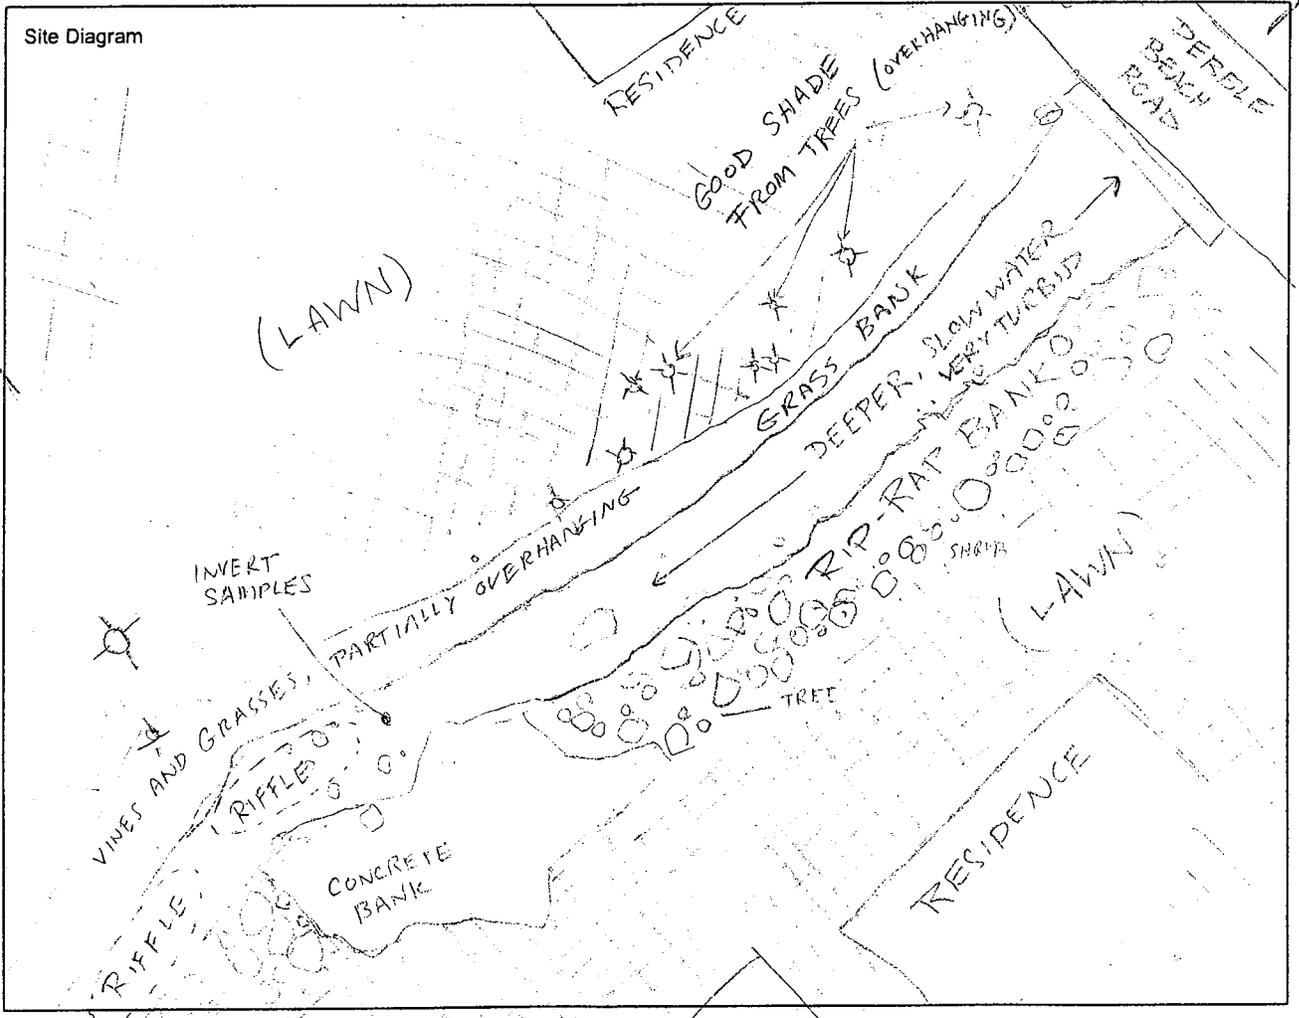
Assessment Scores

Channel condition	<input type="text" value="2"/>	Pools	<input type="text" value="2"/>
Hydrologic alteration	<input type="text" value="3"/>	Invertebrate habitat	<input type="text" value="6"/>
Riparian zone	<input type="text" value="3"/>	Score only if applicable	
Bank stability	<input type="text" value="7"/>	Canopy cover	<input type="text" value="3"/>
Water appearance	<input type="text" value="7"/>	Manure presence	<input type="text" value="NA"/>
Nutrient enrichment	<input type="text" value="5"/>	Salinity	<input type="text" value="5"/> (0.4%)
Barriers to fish movement	<input type="text" value="10"/>	Riffle embeddedness	<input type="text" value="8"/>
Instream fish cover	<input type="text" value="5"/>	Macroinvertebrates Observed (optional)	<input type="text" value="8"/> (74)

Overall score (Total divided by number scored)	<u>5.3</u>	<6.0	Poor
		6.1-7.4	Fair
		7.5-8.9	Good
		>9.0	Excellent

Suspected causes of observed problems RIP-RAP EMBANKMENT AND CONCRETE-LINED BANK REDUCE SUITABLE HABITAT. LAWNS ON EITHER SIDE ALSO ENCRACH ON RIPARIAN CORRIDOR, REDUCING SHADE AND HABITAT. SIGNIFICANT UPSTREAM IMPACTS RESULT FROM D.O.T. STATION, ROADS, AND DEVELOPMENT.

Recommendations REPLACE RIP-RAP WITH MORE VARIED- AND VEGETATED EMBANKMENT. RECOMMEND SET-BACK OF LAWNS AND RESIDENTIAL ACTIVITY FROM STREAM. INVESTIGATE UPSTREAM NUTRIENT INPUTS FROM SOURCES MENTIONED ABOVE.
