The District routinely coordinates and then works with local landowners, farmers and municipalities to address environmental concerns. The following photos highlight a project installed this past summer to alleviate drainage concerns alongside a 1,000 foot section of County Rd 48 located in the town of Groveland.

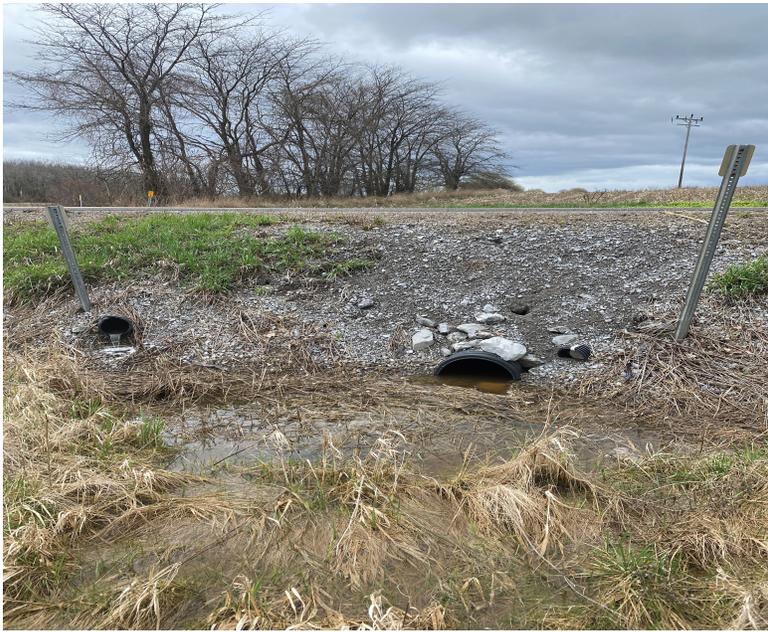
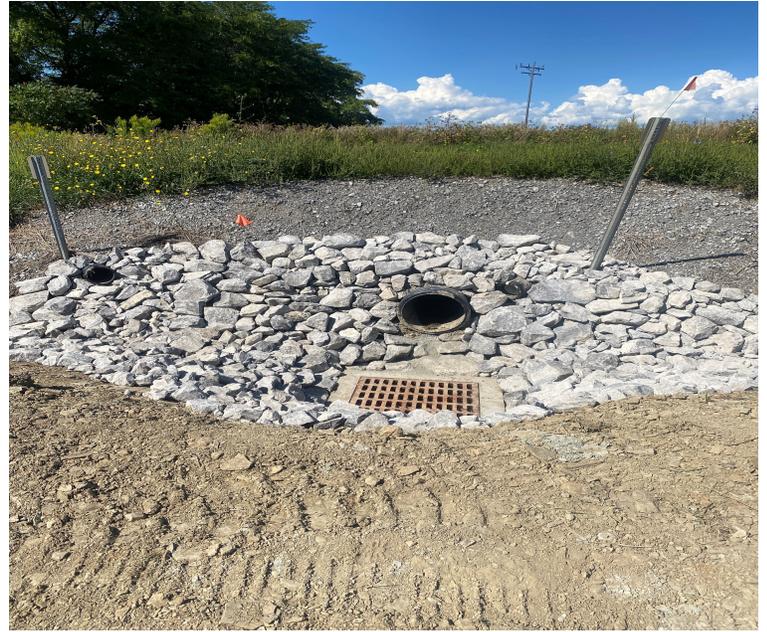
Before Photo: Poor drainage impacts highway, homeowner and vast farmland along County Rd. 48, Groveland, NY
After Photo: Catch basin and underground main installed providing outlet for impounded ground and surface water.

The solution: Installation of two catch basins, 1,300 feet of underground 8" diameter main and 2 natural stone armored stabilized outlets were installed to readily and safely convey ground and storm water drainage downstream.

Results: Erosion, drainage, flooding concerns are addressed. Highway infrastructure, a homeowner's residence and more than 17 acres of prime farmland are significantly improved.

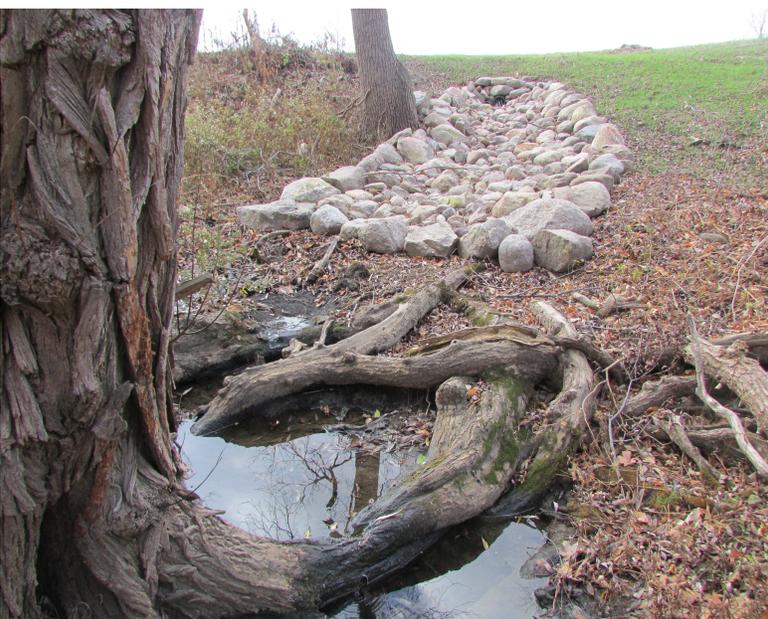
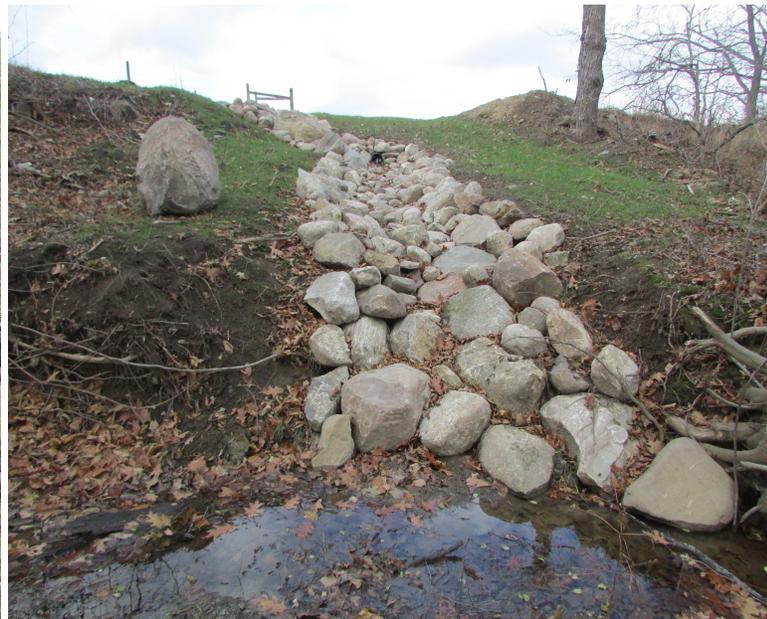
After Photos Below: Locations of 2 stabilized outfalls safely carry and discharge drainage downstream.
