**Town of Livonia
Village of Livonia
Livingston County, New York**

FINAL
**Wilkins Creek Subwatershed
Stormwater Study Report**

December 2018

Barton & Loguidice, D.P.C.
11 Centre Park, Suite 203
Rochester, New York 14614

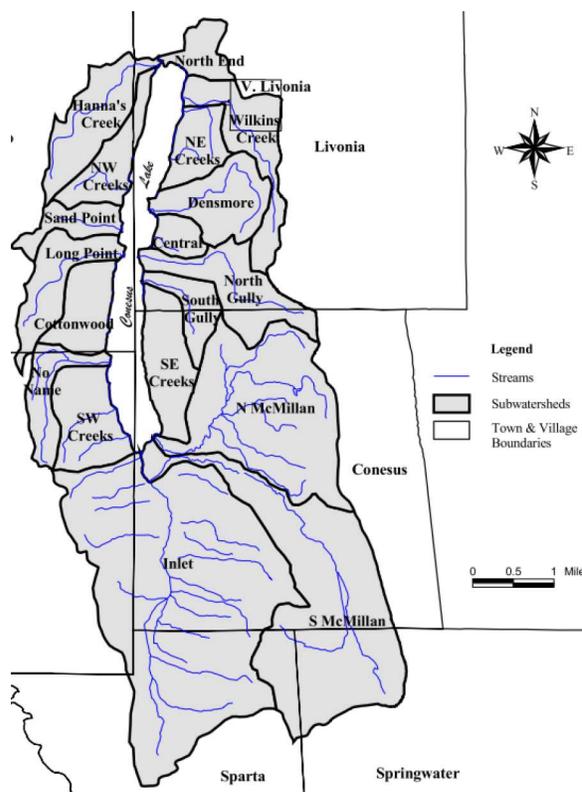
Figure 1-1: Subwatersheds of the Conesus Lake watershed (modified from original source: EcoLogic LLC and Livingston County Planning Department, 2002).

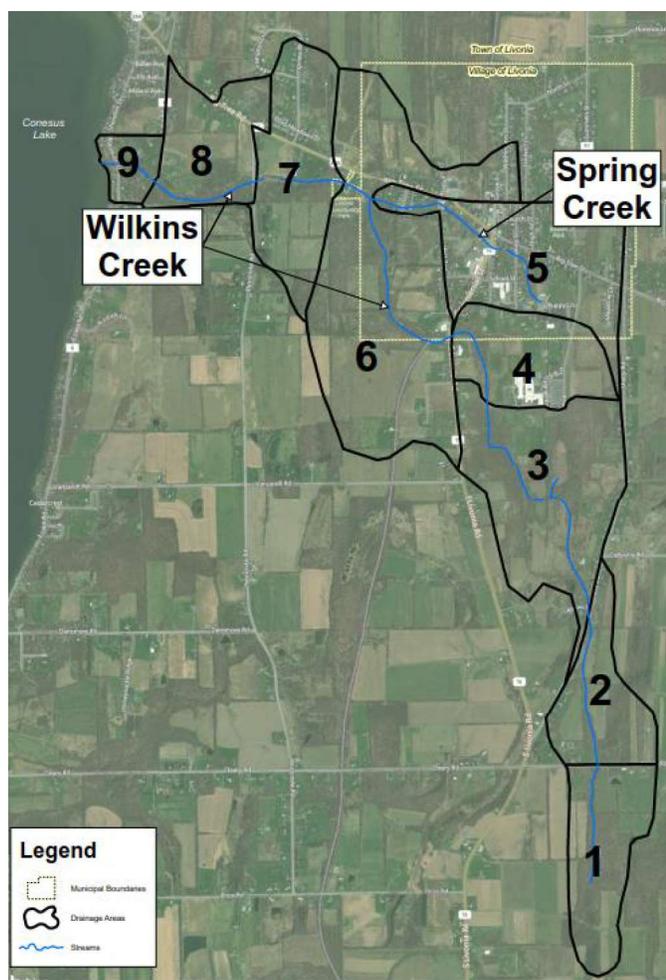
Figure 1-2: Drainage Areas within the Wilkins Creek Watershed

The watershed study area comprises nine separate drainage areas (Drainage Areas 1-9) encompassing nearly 1,424 acres. The drainage areas ultimately direct stormwater runoff downgradient to the northeast shore of Conesus Lake. Drainage areas vary in geologic conditions (*e.g.*, soil type, groundwater level, floodplains, and land cover).

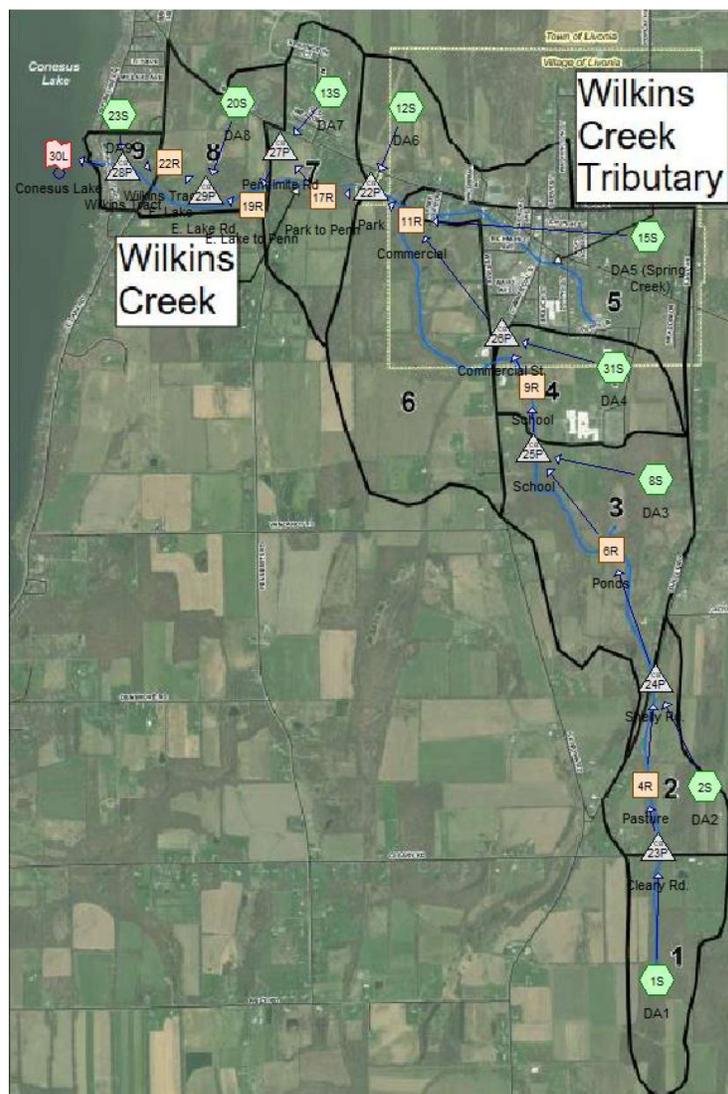
Figure 2-1: Modeled Watershed Study Area

The Watershed Study Area was separated into nine (9) distinct drainage areas (Drainage Areas 1 through 9). Refer to Figure 2-1 for the watershed study area. Ponds (represented as triangles) were utilized within the model to represent a culvert that provides storage under a roadway. Reaches (represented as squares) were utilized to represent channelized flow. Subcatchments (represented as green hexagons) were utilized to represent contributing drainage areas. Modeling assumed reaches operate under free discharge conditions based on normal Manning's flow.

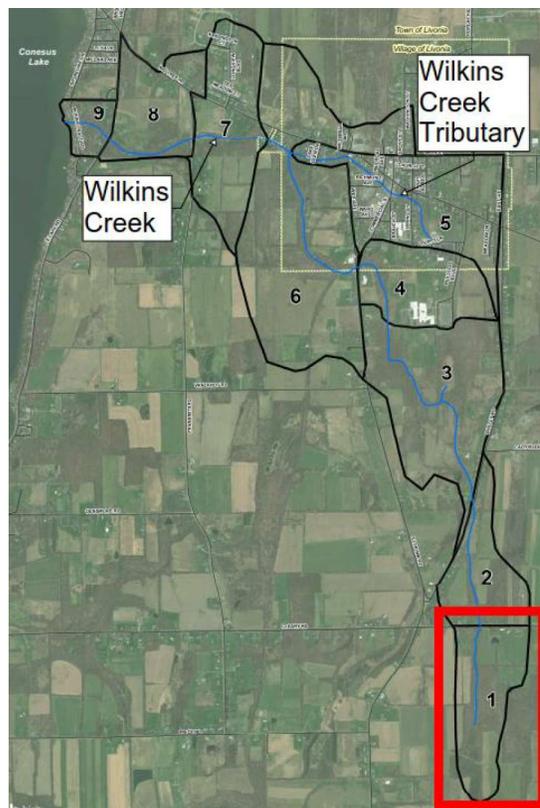
Figure 2-2: Drainage Area 1

Table 2-1: Drainage Area 1 Peak Flow at Cleary Road Culvert	
Drainage Area 1	Modeled Peak Flow at Outlet (cfs)
1-Year Flood	2
1.5-Year Flood	3
2-Year Flood	5
10-Year Flood	21
25-Year Flood	38
50-Year Flood	57
100-Year Flood	82
500-Year Flood	169

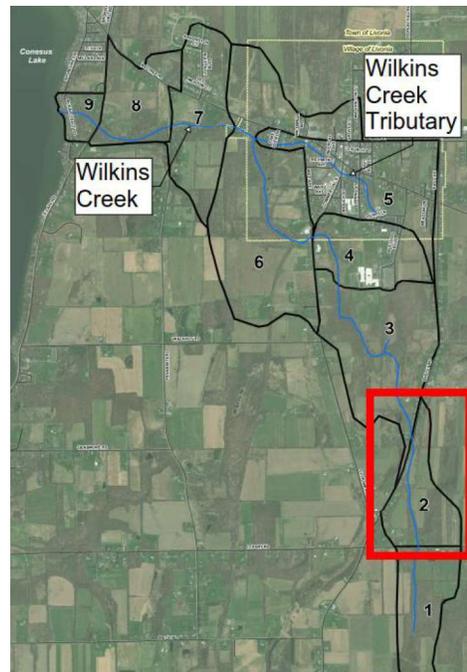
Figure 2-3: Drainage Area 2

Table 2-2: Drainage Area 2 Peak Flow at Shelly Road Culvert	
Drainage Area 2	Modeled Peak Flow at Outlet (cfs)
1-Year Flood	0.4
1.5-Year Flood	0.7
2-Year Flood	1
10-Year Flood	9
25-Year Flood	19
50-Year Flood	32
100-Year Flood	50
500-Year Flood	115

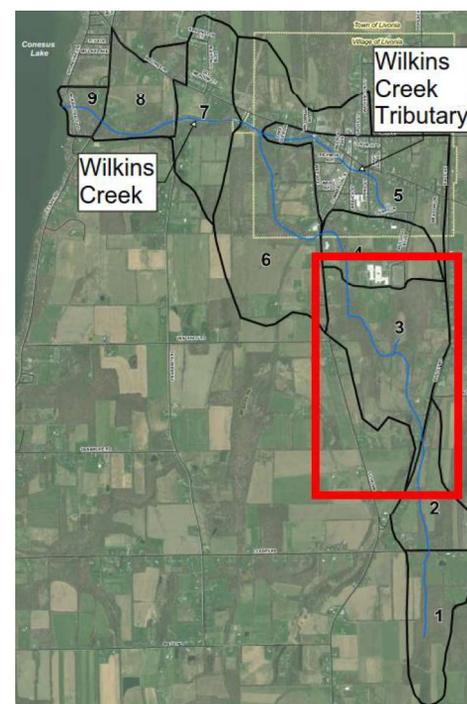
Figure 2-4: Drainage Area 3

Peak flows from Drainage Area 3 are included within **Table 2-3**. The model predicted flooding during the 10-yr storm event along the western entrance to Livonia High School (Bulldog Blvd.) as the culvert underneath the road exceeded capacity causing backwater flooding conditions. Flooding was also modeled to occur during the 100-yr storm event within the reach between Shelly Road and the entrance to the school.

Table 2-3: Drainage Area 3 Peak Flow at Bulldog Boulevard Culvert	
Drainage Area 3	Modeled Peak Flow at Outlet (cfs)
1-Year Flood	2
1.5-Year Flood	3
2-Year Flood	4
10-Year Flood	19
25-Year Flood	36
50-Year Flood	55
100-Year Flood	80
500-Year Flood	169

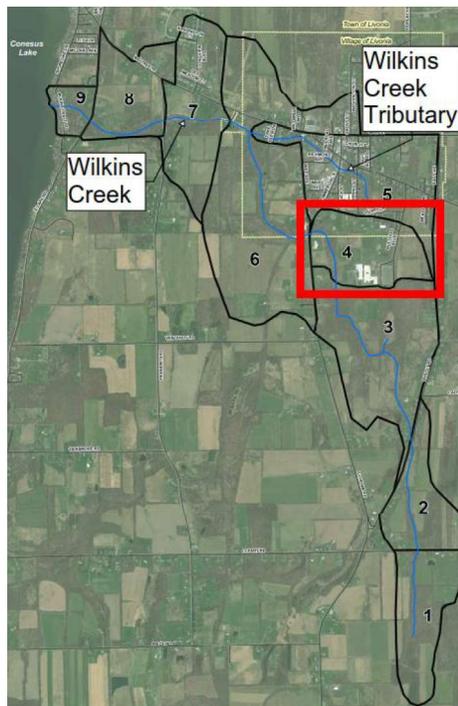
Figure 2-5: Drainage Area 4

Peak flows from Drainage Area 4 are included within **Table 2-4**. The model predicted flooding during the 10-yr storm event around Commercial Street as the culvert underneath the road exceeded capacity causing backwater flooding conditions. The next flooding event occurred during the 100-yr storm event where the model predicted flooding within the reach between the school entrance and Commercial Street.

Table 2-4: Drainage Area 4 Peak Flow at Commercial Street Culvert	
Drainage Area 4	Modeled Peak Flow at Outlet (cfs)
1-Year Flood	3
1.5-Year Flood	4
2-Year Flood	6
10-Year Flood	24
25-Year Flood	43
50-Year Flood	64
100-Year Flood	92
500-Year Flood	185

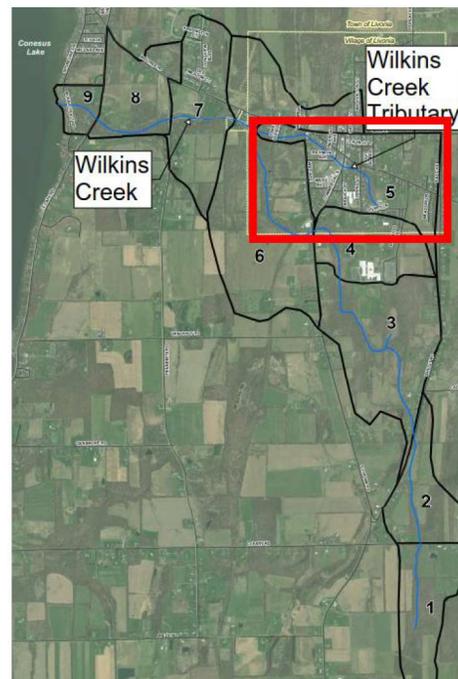
Figure 2-6: Drainage Area 5

Table 2-5: Drainage Area 5 Peak Flow at Wilkins Creek Confluence	
Drainage Area 4B	Modeled Peak Flow at Outlet (cfs)
1-Year Flood	8
1.5-Year Flood	11
2-Year Flood	14
10-Year Flood	41
25-Year Flood	69
50-Year Flood	97
100-Year Flood	132
500-Year Flood	251

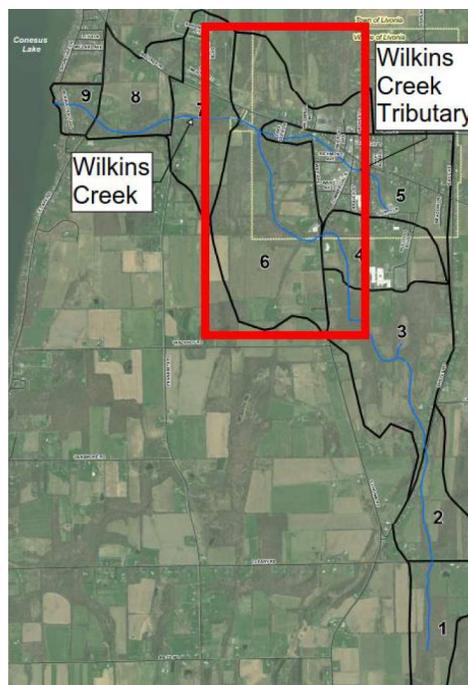
Figure 2-7: Drainage Area 6

Peak flows from Drainage Area 6 are included within **Table 2-6**. The model predicted flooding during the 25-yr storm event within the Livonia Community Park where the culvert underneath the entrance exceeded capacity, causing backwater flooding conditions. The next flooding event occurred during the 500-yr storm event within the reach between Commercial Street and the Park entrance.

Table 2-6: Drainage Area 6 Peak Flow at Livonia Community Park Culvert	
Drainage Area 5	Modeled Peak Flow at Outlet (cfs)
1-Year Flood	22
1.5-Year Flood	29
2-Year Flood	38
10-Year Flood	113
25-Year Flood	187
50-Year Flood	261
100-Year Flood	354
500-Year Flood	660

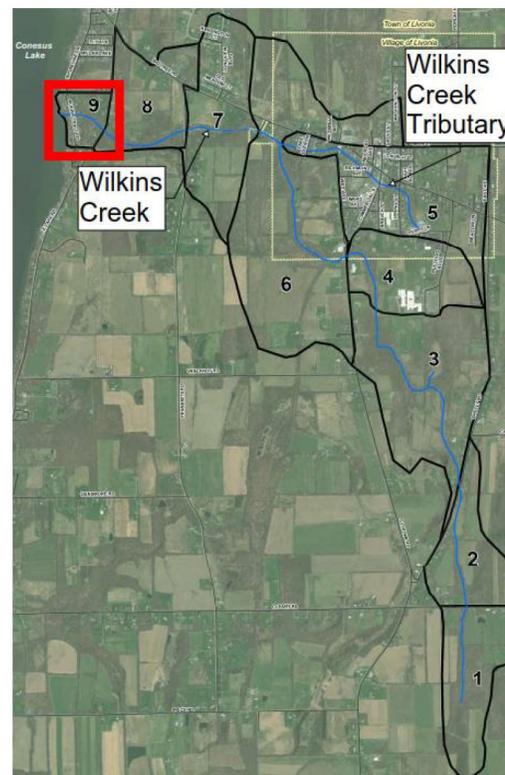
Figure 2-10: Drainage Area 9

Table 2-9: Drainage Area 9 Peak Flow at Wilkins Tract Culvert	
Drainage Area 6	Modeled Peak Flow at Outlet (cfs)
1-Year Flood	8
1.5-Year Flood	10
2-Year Flood	12
10-Year Flood	26
25-Year Flood	39
50-Year Flood	51
100-Year Flood	66
500-Year Flood	112

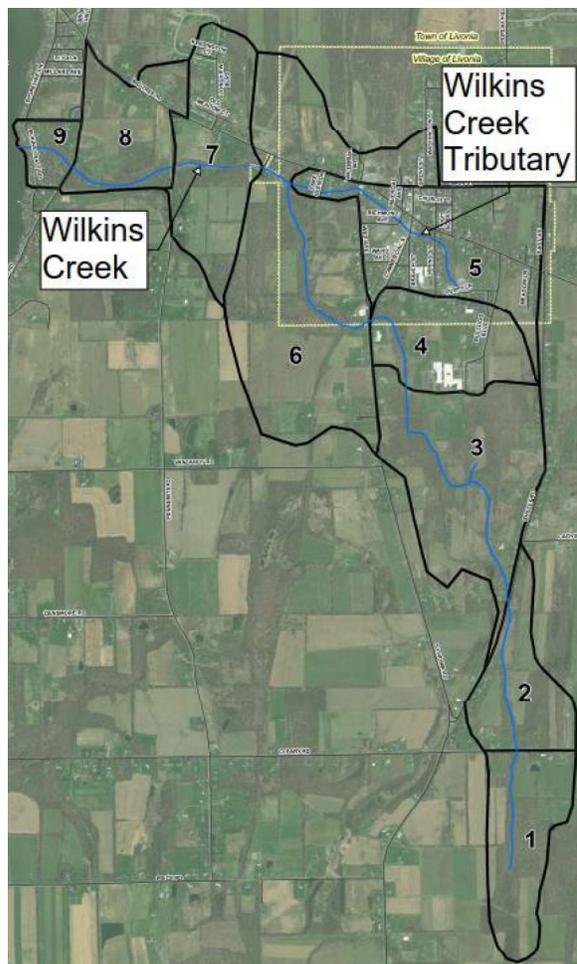
Figure 2-11: Drainage Areas

Table 2-10. Phosphorus Loading Summary				
Drainage Area	Area (ac)	P Loading Rates (lb/ac)	Total P Loading (lbs)	Percent of Total P Loading (%)
1	115	0.25	28.8	7.8%
2	98	0.20	19.8	5.4%
3	229	0.19	43.7	11.8%
4	115	0.22	25.0	6.8%
5	196	0.16	31.4	8.5%
6	386	0.19	74.7	20.2%
7	148	0.69	102.6	27.8%
8	107	0.33	35.3	9.6%
9	30	0.26	7.82	2.1%
Total	1,424 ac	0.26 lb/ac	369.1 lbs	100%

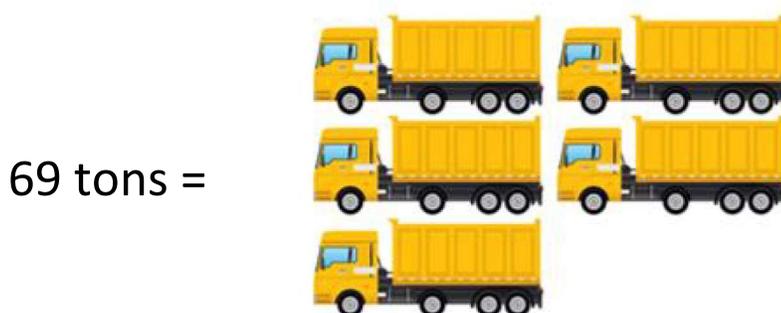
Figure 2-12¹: 69 tons equates to approximately 5 dump trucks of sediment

Sediment loading rates and total sediment loads for each basin are summarized in **Table 2-12**. It is estimated that sediment is eroded at a rate of approximately 96.7 lb/ac on average within the entire study area, with annual sediment loads of approximately 137,640 lbs (69 tons) from non-point sources that ultimately deposit in the lake. This equates to approximately 5 dump truck loads of sediment to the Lake each year (based on 10 cubic yards per truck). Drainage Areas 7 and 8 have the greatest sediment loading rates. It should be noted that the Mapshed model is a generalized model and does not include localized streambank erosion encountered during the field reconnaissance. Therefore, it is reasonable to assume larger sediment loads are going to the Lake, especially in areas of high bank erosion (e.g., Drainage Area 7).

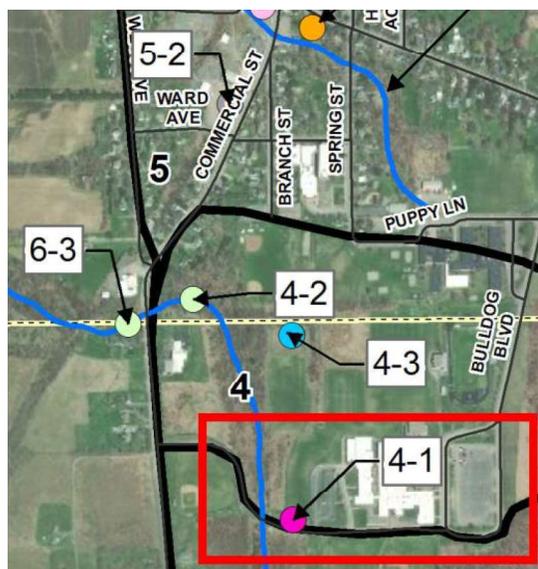
Figure 3-1: Project 4-1 Location

Project No. 4-1: Livonia High School Green Infrastructure (GI) incorporates multiple GI practices strategically located to treat higher concentrated flows. One GI practice includes expansion of an existing rain garden (see Photo 8 in **Appendix F** located at the end of this report) to manage and treat stormwater runoff using a conditioned planting soil bed and planting materials to filter runoff stored within a shallow depression. Currently, the existing rain garden is not strategically located as it is above a culvert that discharges stormwater runoff from upper parking lots where it is unable to filter runoff.

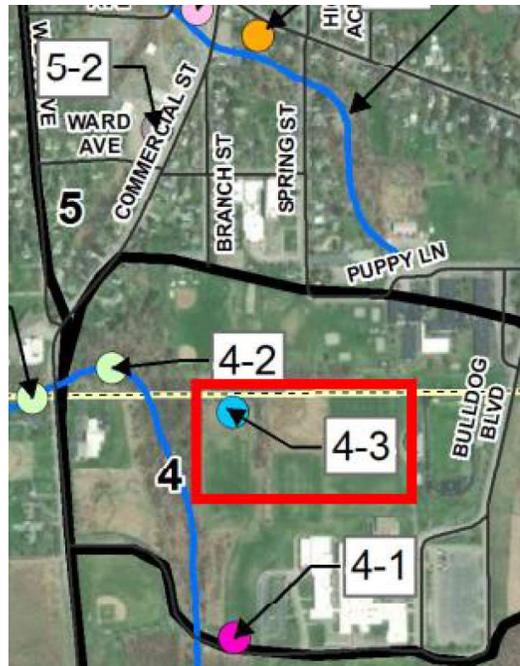
Figure 3-2: Project 4-3 Location

Project No. 4-3: Livonia High School Pond Retrofit transforms an unused field on school grounds adjacent to Myers Field (see Photo 20 in **Appendix F**) into an opportunity to provide additional stormwater storage and reduce peak flows downstream. Currently, three 12-inch culvert drain into Wilkins Creek that are believed to be coming from the school parking lot. An opportunity exists to disconnect and reroute drainage from the parking lot and fields to the pond. A pond could be constructed between Wilkins Creek and the parking lot to increase stormwater storage capacity, reduce peak flows downstream, and increase aquatic and riparian vegetation. An outflow control device could be installed to allow more aquatic and riparian vegetation to thrive enhancing pollutant removal and reducing peak flows, further reducing downstream erosion. Water quality benefits are summarized below:

- Pond Retrofit (assumed 34,800 square feet)
 - Total Phosphorus: 12.5 lb/yr reduction
 - Total Nitrogen: 34.6 lb/yr reduction
 - Sediment: 9,000 lb/yr reduction

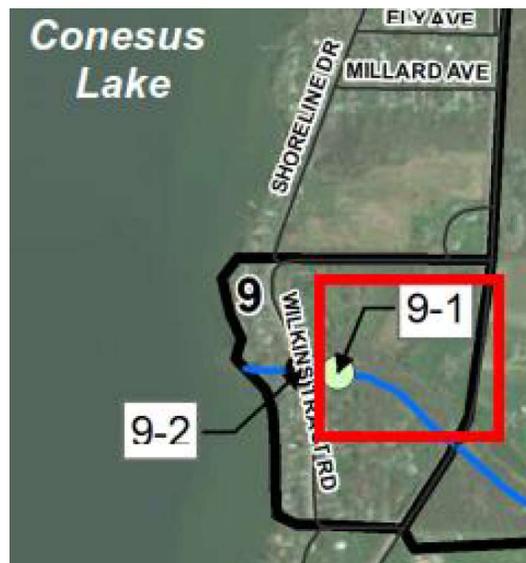
Figure 3-3: Project 9-1 Location

Project No. 9-1: Streambank Stabilization within 6143 Wilkins Tract, 6073 Wilkins Tract, 3890 East Lake Road, and 3900 East Lake Road incorporates improved floodplain connectivity, riparian vegetation, and stabilized streambanks to protect residential properties from erosion along Wilkins Creek. As a result, peak flows and sediment loads can decrease, improving water quality. The existing Creek widened by eroding adjacent banks (see Photos 2 and 3 in **Appendix F**) due to the absence of an adequate floodplain to absorb excess flows and reduce water velocities, can be transformed into a stabilized, riparian vegetated, Creek. The Spreadsheet Tool for Estimating Pollutant Load (STEPL) program developed by the EPA estimated the approximate nutrient and sediment load reductions below:

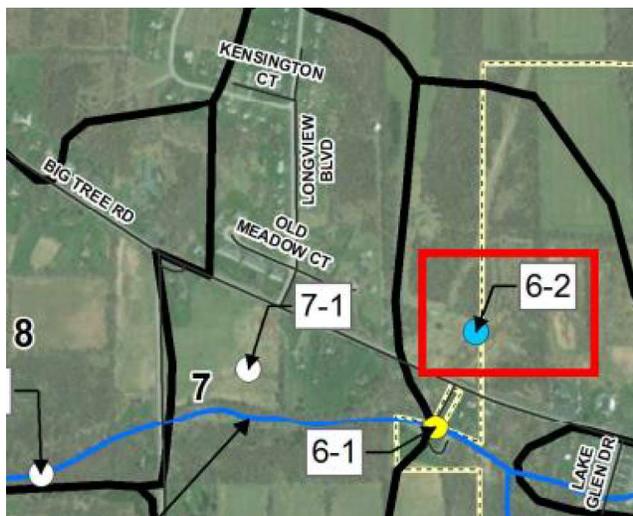
Figure 3-4: Project 6-2 Location

Project No. 6-2: Pond retrofit within 6241 Big Tree Road and adjacent lot with Tax Map ID 74.8-1-1 on Big Tree Road transforms an overgrown field into an opportunity to provide additional stormwater storage and reduce peak flows downstream. Currently, an existing drainage path contributes flow to Wilkins Creek north of Big Tree Street (see Photo 21 in **Appendix F**). A pond could be constructed adjacent to the drainage path to increase stormwater storage capacity, reduce peak flows downstream, and increase aquatic and riparian vegetation. An outflow control device could be installed to allow more aquatic and riparian vegetation to thrive enhancing pollutant removal and reducing peak flows, further reducing downstream erosion. Water quantity and quality benefits are summarized below:

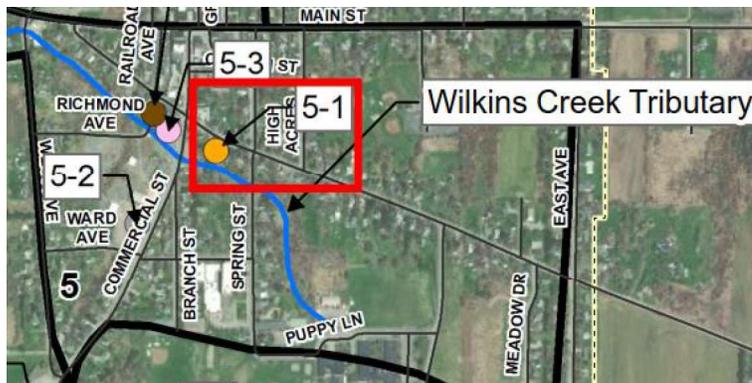
Figure 3-5: Project 5-1 Location

Project No. 5-1: Reduction in impervious area (porous pavement):

incorporates a green infrastructure retrofit of public parking lots (*i.e.*, Gazette, Keystone, Prettejohn, Field, and Brooks) within the Village of Livonia (see Photo 17 in **Appendix F**). As technology allows, porous pavement can be used to reduce impervious area. The reduction in impervious area transforms existing impermeable parking lots into a green infrastructure practice that can provide significant benefits for stormwater management, while at the same time educating the public by incorporating signage. Educational kiosks can provide interpretive information on the green infrastructure practice deployed within the Village. The kiosks can utilize graphically oriented visual displays to educate visitors about the important links between the built environment and water quality in the Lake. The reduction in impermeable area can reduce peak flows and pollutant runoff. STEPL estimated the approximate nutrient and sediment load reductions below:

- Reduction in Impervious Area (assumed 71,300 square feet mitigated)
 - Total Phosphorus: 0.6 lb/yr reduction
 - Total Nitrogen: 8.1 lb/yr reduction
 - Sediment: 400 lb/yr reduction

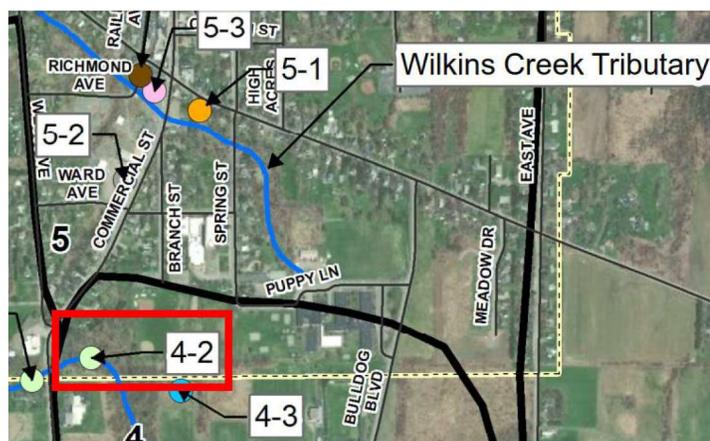
Figure 3-6: Project 4-2 Location

Project 4-2: Streambank Stabilization

behind the Livonia Fire Department on South Livonia Road within Village owned property (Tax Map IDs 75.13-1-19.1 and 75.-1-45.11) incorporates improved floodplain connectivity, riparian vegetation, and stabilized streambanks to reduce lateral migration and erosion of the streambanks. As a result, peak flows and sediment loads can decrease, improving water quality. The Creek has been experiencing lateral migration, presumed to be caused by increased peak flows upstream after the addition of athletic fields that channelized flow to the Creek (see Photo 5 in **Appendix F**). The Creek can be transformed into a stabilized, riparian vegetated Creek. STEPL estimated the approximate nutrient and sediment load reductions below:

- Streambank Stabilization (assumed 110 linear feet mitigated)
 - Total Phosphorus: 1.5 lb/yr reduction
 - Total Nitrogen: 3.5 lb/yr reduction
 - Sediment: 2,400 lb/yr reduction

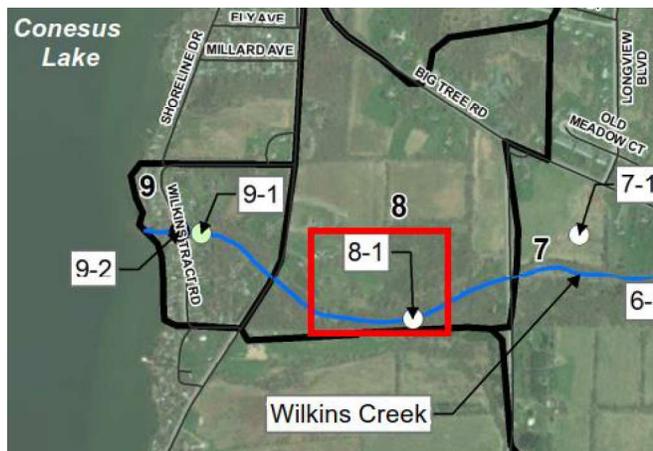
Figure 3-7: Project 8-1 Location

Project No. 8-1: Stormwater Management Area within 3895 East Lake Road and adjacent lot with Tax Map ID 74.-1-13.132 between East Lake Road and Pennemite Road incorporates a constructed wetland between Pennemite Road and East Lake Road. The Stormwater Management Area transforms an existing wooded area with a relatively high groundwater table upstream of major bank erosion near Wilkins Tract that can provide significant water quality and quantity benefits (see Photo 4 in **Appendix F**). The constructed

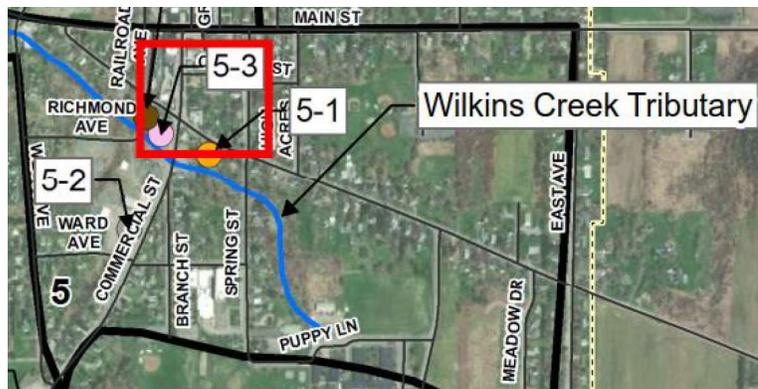
Figure 3-8: Project 5-3 Location

Project 5-3: Village GI incorporates a green infrastructure retrofit of Commercial and Main Street within the Village center. The GI transforms an existing impermeable sidewalk into a suite of green infrastructure practices enhancing the traditional charm of the Village center (see Photos 13 to 15 in **Appendix F**). The project includes a Permeable Interlocking Concrete Pavement System and a stormwater tree trench with Cornell University structural soils. The conventional impervious sidewalk could be replaced with a Permeable Interlocking Concrete Pavement (PICP). PICP systems are solid concrete paving units that form an interlocking pattern. Small joints between the units are filled with pervious material that allow water to infiltrate to a

structurally supportive reservoir course of open graded aggregates. The reservoir course stores water and allows it to infiltrate into the soil subgrade, or release gradually downstream. Perforated underdrains in the reservoir course are used to remove water that does not infiltrate within a given design period. In addition to providing water quantity and quality benefits, the concept can provide public education to the local community. Educational kiosks can provide interpretive information on the green infrastructure practices deployed within the Village. The kiosks can utilize graphically oriented visual displays to educate visitors about the important links between the built environment and water quality in the Lake. The overall concept of Village GI can provide public education, water quantity and quality benefits, improve air quality, and reduce urban heat island effects. The following STEPL benefits were calculated:

- Village GI (assumed 11,000 square feet mitigated)
 - Total Phosphorus: 0.1 lb/yr reduction
 - Total Nitrogen: 0.8 lb/yr reduction
 - Sediment: 41.1 lb/yr reduction

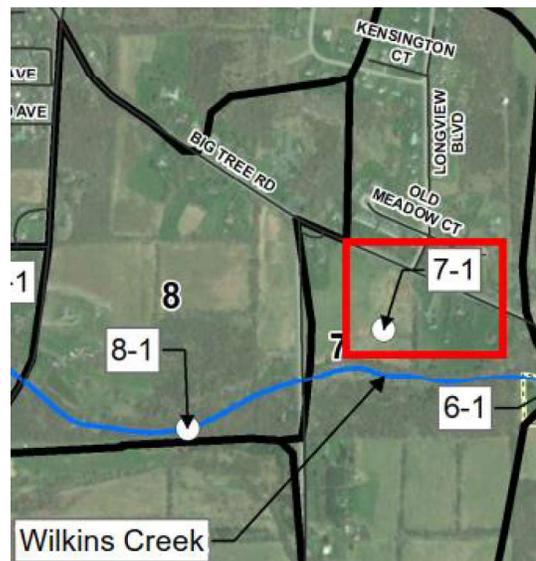
Figure 3-9: Project 7-1 Location

Project No. 7-1: Stormwater Management Area within 6241 Big Tree Road incorporates a constructed wetland with bioretention basins at the property south of Big Tree Street (see Photo 22 in **Appendix F**). The Stormwater Management Area could transform an existing overgrown field with a relatively high groundwater table downgradient of the recently built Longview development to a sustainable area that can provide significant water quality and quantity benefits. Bioretention basins or bioswales could collect and treat runoff from the Longview development prior to discharge to the wetland. Flow from the bioretention basin/bioswales could be diverted through the wetland for treatment before returning to the Creek prior to the Pennemite Road culvert. The constructed wetland system could be designed to maximize the removal of pollutants through settling of sediments and both uptake and filtering by native wetland vegetation. A marsh wetland designed with sinuous pathways can

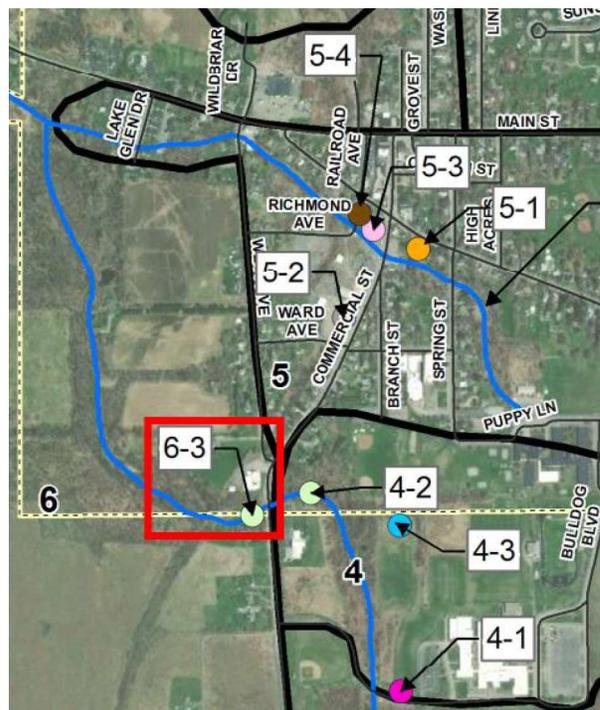
Figure 3-10: Project 6-3 Location

Project 6-3: Streambank Stabilization within 4212 South Livonia Road incorporates improved floodplain connectivity, cross vane, riparian vegetation, and stabilized streambanks to reduce lateral migration and erosion of the streambank that is causing property loss (see Photo 12 in **Appendix F**). The Creek could be transformed into a stabilized, riparian vegetated Creek. The cross vane could be installed just downstream of the culvert carrying flow under Commercial Street to channelize flow away from the eroded streambanks. As a result of the transformation, peak flows and sediment loads can decrease, improving water quality. STEPL estimated the approximate nutrient and sediment load reductions below:

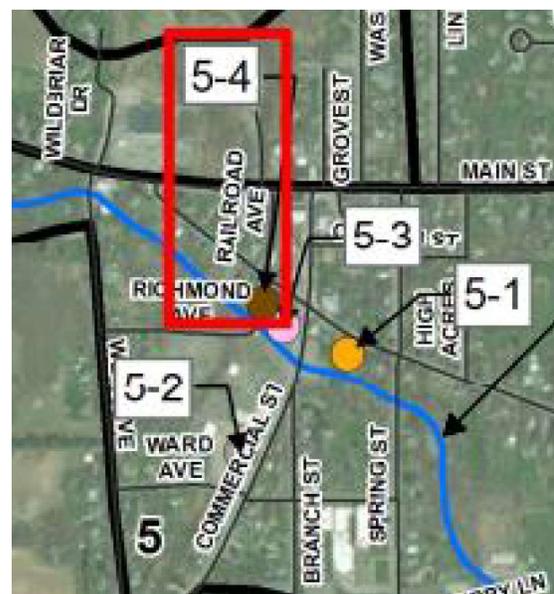
Figure 3-12: Project 5-4 Location

Project 5-4: Underground Storage under the Brooks Public Parking Lot incorporates subsurface stormwater detention to capture and store stormwater runoff collected from surrounding impervious areas (*i.e.*, Gazette, Keystone, Prettejohn, Field, and Brooks Public Parking Lots). The underground storage facility could be sized to capture runoff originating from a 10-year storm from the public parking lots within the Village by incorporating two 10-foot effective diameter chambers measuring 120 feet long. The storage facility could decrease the peak flow when used with a controlled flow orifice at the outlet. Although minimal water quality benefits would be achieved, this recommendation could greatly reduce peak flows downstream. This approach could be paired with porous pavement (see Project 5-1) or used as a standalone practice.

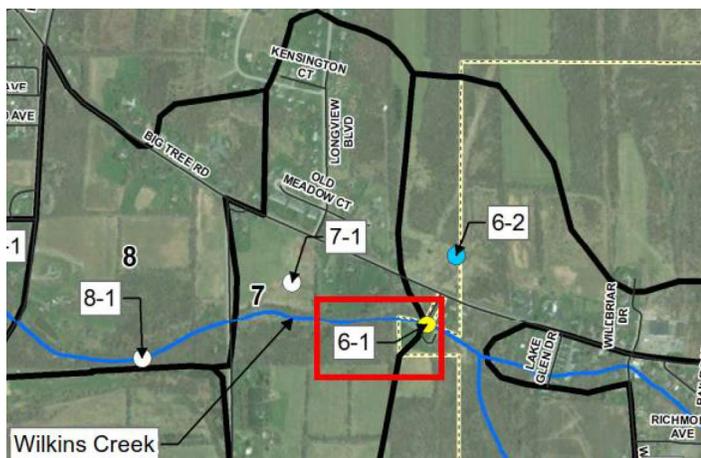
Figure 3-14: Project 6-1 Location

Project 6-1: Culvert Modification within the Livonia Community Park transforms an existing culvert under the Park entrance that conveys flow along Wilkins Creek to an arch-shaped culvert with corresponding floodplain bench culverts (see Photo 18 in **Appendix F**). The proposed transformation closer mimics stream hydraulics with a prescribed low flow culvert and floodplain bench to reduce potential for scour eddies downstream. As a result, the localized erosion and stream instability can be reduced, further reducing sediment load. Water quality benefits are summarized below:

- Culvert Modification (assumed 20 linear feet mitigated)
 - Total Phosphorus: 0.3 lb/yr reduction
 - Total Nitrogen: 0.6 lb/yr reduction
 - Sediment: 400 lb/yr reduction

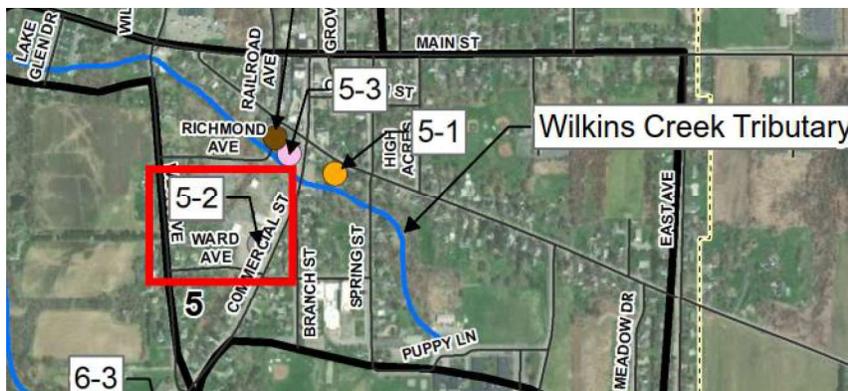
Figure 3-15: Project 5-2 Location

Project 5-2: Salt Storage Modification on the Town and Village of Livonia properties along Commercial Street could transform two existing salt storage buildings (see Photos 11 and 23 in **Appendix F**) somewhat exposed to the environment

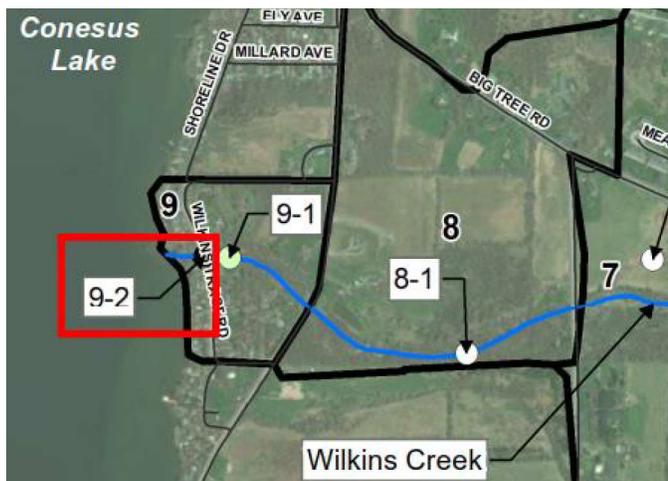
Figure 3-16: Project 9-2 Location

Project 9-2: Wing Wall Restoration adjacent to 6144 Wilkins Tract transforms an existing wing wall that has been on the verge of failure into a stabilized structure. The wing wall is currently settling, with heavy storm events eroding the surrounding soil. In time, the wing wall and portions of the adjacent residential yard can cave into the Creek creating sediment deposits. Water quantity benefits can be approximated by the assumed amount of sediment the wing wall is holding back which is approximately 200 lbs of sediment. In addition to the water quantity benefits, wing wall restoration is believed to be necessary as a safety precaution due to the proximity to Wilkins Tract and residential property.

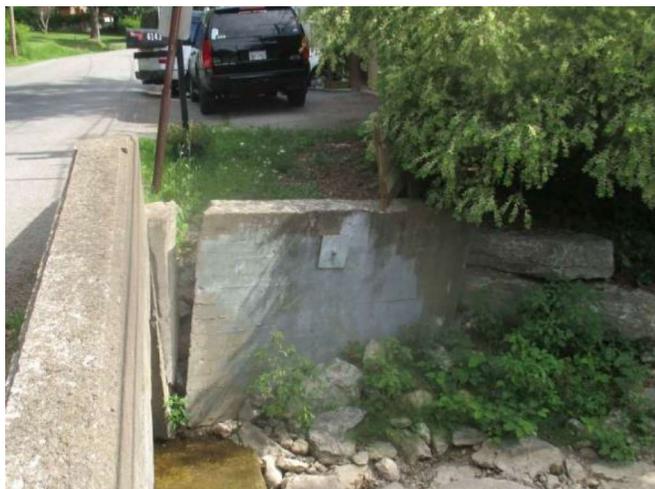
Figure 3-17: Project 9-2 Wing Wall Degradation
