Streambank Remediation Study Final Report

**Conesus Lake Watershed
Livingston County Planning Department**

Stantec

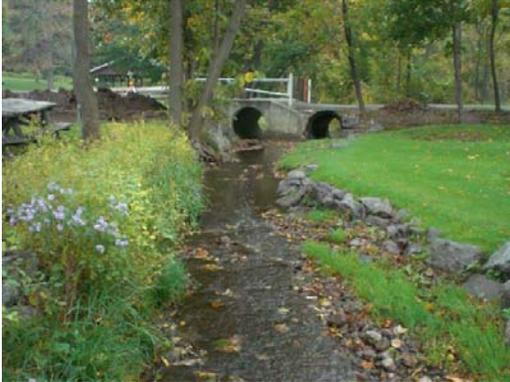
The upper reach of Wilkins Creek is flowing through a park. This reach is well connected to the floodplain. The buffer on much of this reach has been removed. Rock boulders have been placed at the toe of the bank to hold the bank toe in place. There is a double culvert that is misaligned with the stream channel and does produce scour eddies during high flow.

Photo 1 – Boulder toe protection

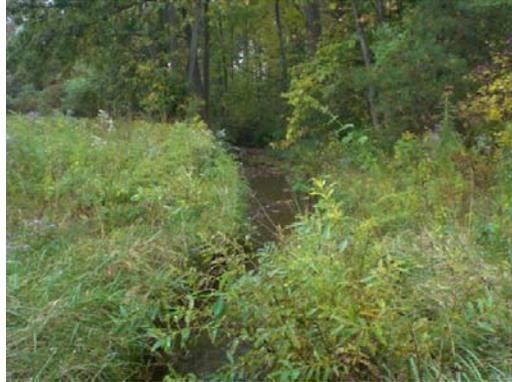
Photo 2 – Vegetation & floodplain connection

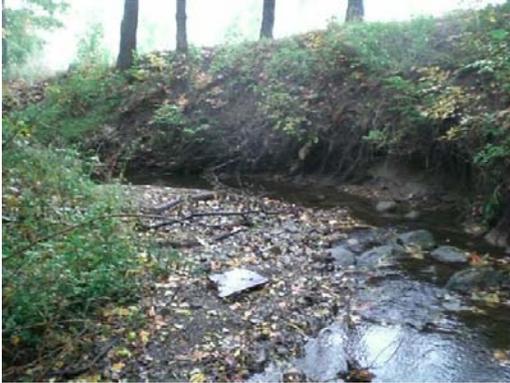
bank erosion and instability. At the lower end of the reach the stream approaches re-connection to the floodplain.

Photo 3 – Bank erosion detached from floodplain

The upper middle reach will continue to be unstable until the floodplain has reached a stable form. The upper middle reach has significant bank migration. The upper middle reach will continue to be laterally unstable until the floodplain has reached a stable form. The water and sediment supply of the watershed will dictate the stable form of the stream channel. The current bank migration, bank erosion, and chute cutoffs will continue to add to the sediment supply of this reach.

The upper middle reach of Wilkins has significant bank erosion which in turn dominates the sediment load. It is recommended that the middle reach be relocated, the related floodplain be re-graded and the banks be stabilized to deal with the current watershed. The 2,000 ft channel relocation/restoration will utilize ***log vanes*** and ***rock vanes*** to stabilize and hold grade for the relocated channel. ***Rock vanes*** will be used to divert flows from foundations. ***Brush mattresses*** and cutting a ***bankfull bench*** will provide bank stability and reduce the near bank stress. (Specifications and details for bold/italicized items can be found in the Appendix).

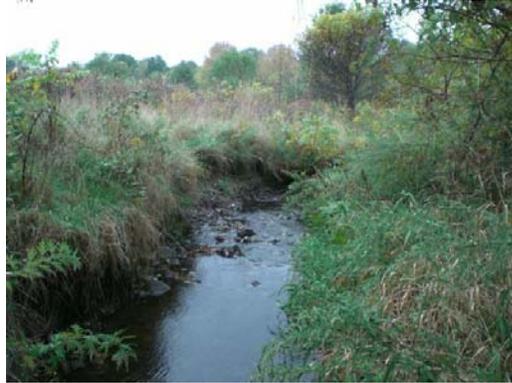
Photo 4 – Bank erosion - attached floodplain

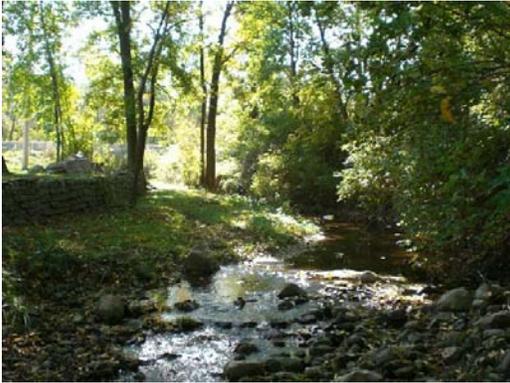
evidence that this reach has been dredged to remove the aggradation. A terrace on the left bank confines the channel and there is severe bank erosion in multiple locations. The channel has a limited buffer and there is bank erosion on the outside of the meander bends due to bank migration.

Photo 5 – Levee and meandering channel

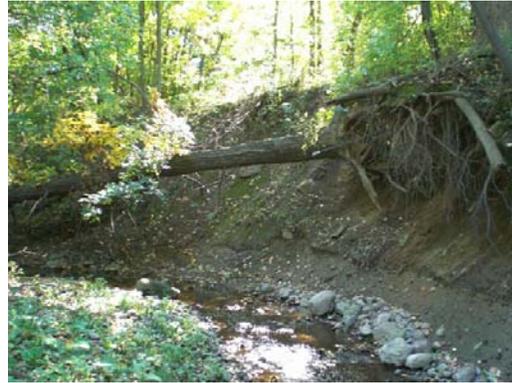
Photo 6 – Bank erosion cut terrace

The lower middle reach will continue to be laterally unstable until the floodplain has reached a stable form. The floodplain is beginning to form in this reach. The water and sediment supply of the watershed will dictate the stable form of the stream channel. Once the upstream section has eroded enough material to carve a floodplain at a lower elevation, the sediment transported will aggrade and form sediment bars that will accelerate the bank migration rate. There will continue to be large quantities of mass wasting of banks and terraces.

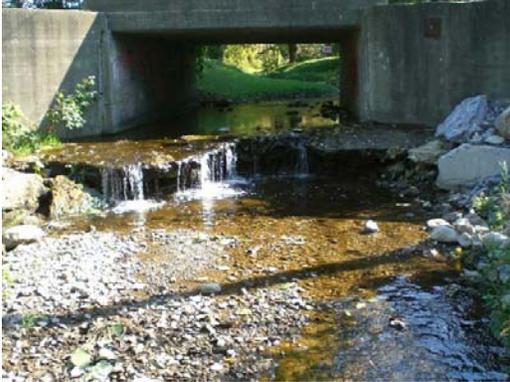
movement of the headcut is limited by the roadway culvert. The lower reach of this stream is under backwater influence for 200 ft.

Photo 7 – Headcut and culvert

The lower reach of Wilkins Creek will continue be fairly stable. The headcut has reached the culvert and there is no significant drop over this reach with the exception of the drop coming out of the culvert.

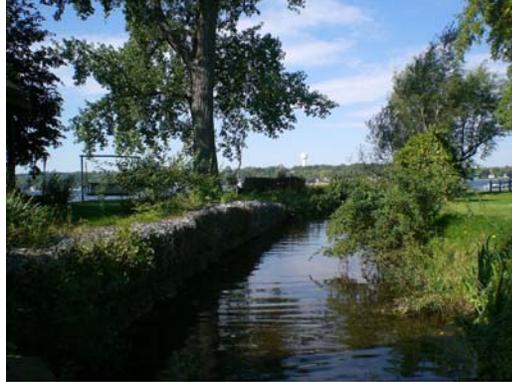
Photo 8- Wilkins Creek and Conesus Lake

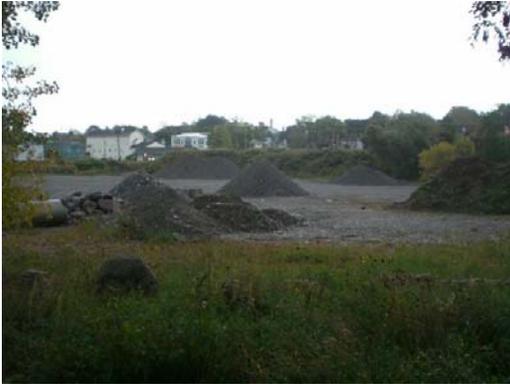
Photo 1 – Maintenance yard

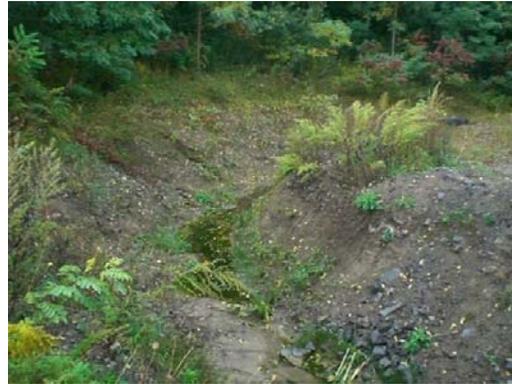
The upper reach of UT Wilkins is an ephemeral channel and starts as a perimeter ditch for the maintenance yard and stockpile area. This reach is 600 ft in length and is a v-shaped drainage ditch that is vertically confined by two culverts and has a nearly flat slope. The banks of the reach are not well vegetated. This reach is part of a perimeter ditch for a maintenance yard and stockpile area.

Photo 2 – V shaped perimeter ditch

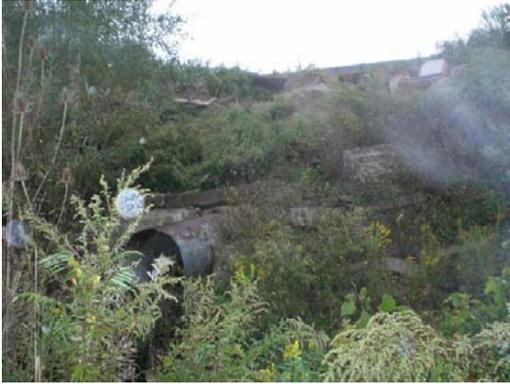
Photo 3 – Outfalls and pipes

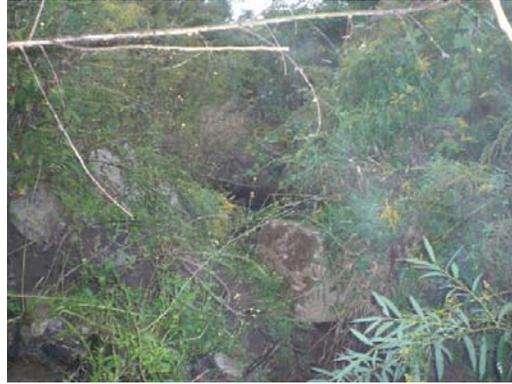
The middle reach of the UT to Wilkins Creek is a transitional steep gradient channel. The maintenance yard is at a higher elevation than the former floodplain valley. The valley was filled and graded to create a level maintenance yard. The drop from the top of the maintenance yard and the perimeter ditch is about 30 ft over a length of 100 ft. Even with low flow rates this is an incredibly unstable feature. The concentrated flows from stormdrains accelerate the local erosion and scour in this reach. Large rocks and boulders have been placed at the toe of the headcut or transition to hold grade. There is a very poor quality riparian buffer over most of this reach.

Photo 4 – Grade drop and related headcut

The middle reach will continue to be both vertically and laterally unstable until the channel carves a new valley through the fill material. Currently the sediment supply on this reach is dominated by sediment from bank erosion. There is very little chance of this channel stabilizing naturally. The placed rock will slow the rate of vertical migration.

The valley should be re-graded over a longer length to decrease the slope and structures should be installed to hold grade and protect the banks. The 600 ft relocation/restoration will utilize **rock cross vanes** to stabilize and hold grade for the relocated channel. **Brush mattresses** and cutting a new floodplain valley will provide bank stability and reduce the near bank stress. (Specifications and details for bold/italicized items can be found in the Appendix)

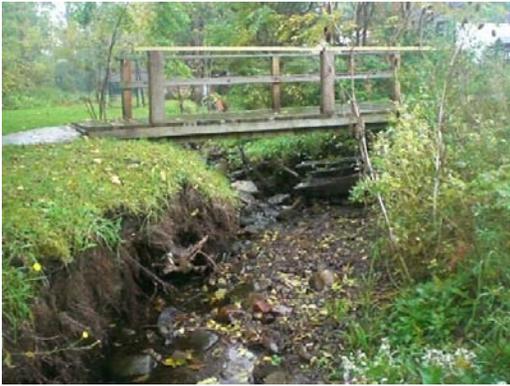
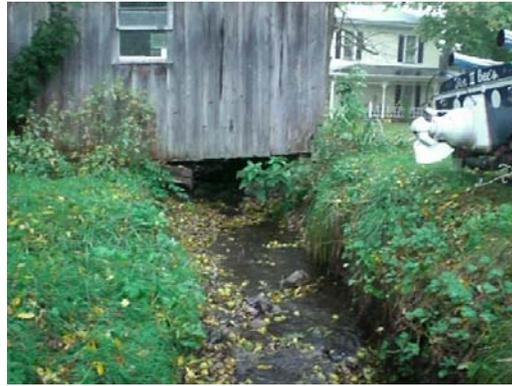
The lower reach of UT Wilkins is 600 ft. This reach is detached from the floodplain and has significant bank erosion. There is very little riparian buffer where the UT flows through the backyards of 4-8 residential dwellings. There is a residential out-building that is located above the stream channel. A 24" elliptical culvert vertically confines the lower end of this reach.

Photo 5 – Bank erosion residential backyards Photo 6- Residential out-building

The lower reach of UT Wilkins will continue to cut away at both banks. While bank erosion will continue the stream is confined laterally and will not have a greater departure from the floodplain.

On the lower reach, flood protection and property protection are the primary goals. The existing channel is detached from the floodplain and there is bank erosion. A small **bankfull bench** should be constructed on the left bank. In addition the landowners should be informed about stream restoration and riparian buffer function. It is also recommended that a minimum 25ft buffer be maintained over the entire reach.

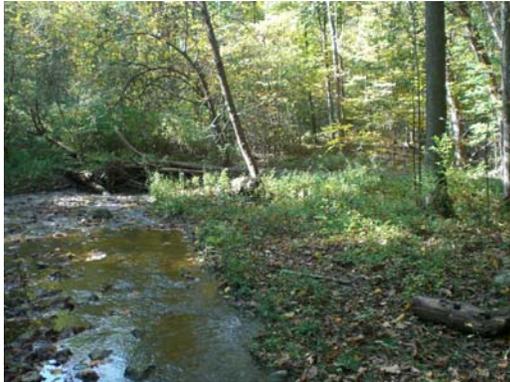
The upper reach of Densmore is a stable channel connected to its floodplain. This results in a low shear stress. The banks are well vegetated and stable. There is very little bank erosion on this reach. There is an embankment and 12 inch culvert set at grade at the lower end of the upper reach of Densmore Creek. This reach is approximately 700ft in length.

Photo 1 – Upstream stable reach

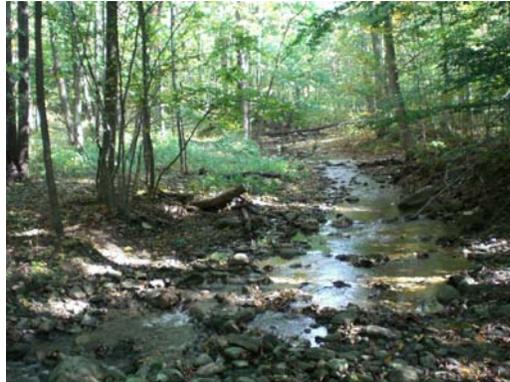
Photo 2 –vegetation & floodplain connection

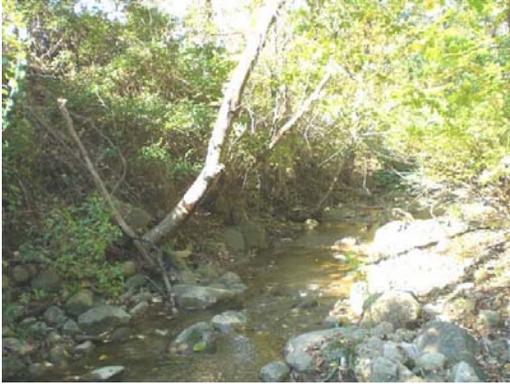
The upper middle reach of Densmore is approximately 600 ft. This reach has significant bank erosion and bank migration. The eroding banks are composed of alluvium not shale outcrops. The left bank migration is threatening the stability of Cleary Road. There is a 50ft or greater buffer on both banks of this reach. This incised reach displays a very sinuous channel that is moderately down cut from the historic elevation.

Photo 3 – Bank erosion near road

The upper middle reach of Densmore Creek has moderate sediment loading. The bank migration will continue on the left bank and increase chance for hillslope erosion and possible failure of the subgrade and berm of Cleary Road. The major source of eroded sediment from the bank migration is at low production rate and limited to a 400 ft section of stream.

This reach should be observed with bank erosion pins over the next couple of years to assess the risk of roadway damage due bank erosion. Bank erosion pins allow for measurement of the annual bank migration rate. If the bank migration rate is at a rate that will risk the integrity of Cleary Road, then the channel should be relocated or structures should be installed to protect the bank from erosion and accelerated bank migration.

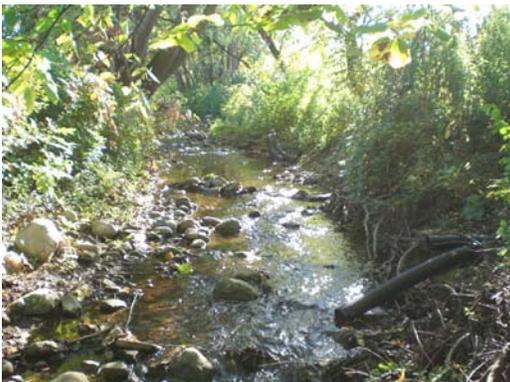
The middle reach of Densmore is approximately 1,100ft. This stream reach is moderately stable and slightly incised. The channel does not have a high percentage of embedded fine sediments. There are various field drains and rooftop runoff drains that are directly discharging to the stream.

Photo 5 –Rooftop runoff and drainage

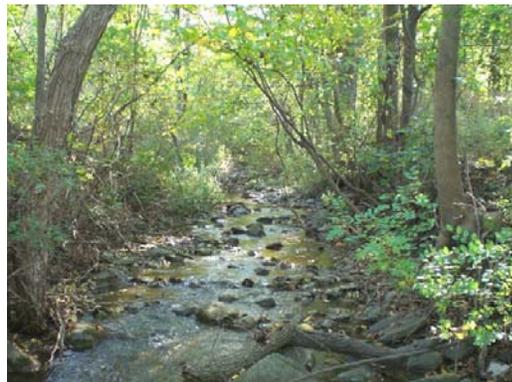
Photo 6 – Moderately stable channel

The middle reach will continue to be moderately stable and will become more stable as the lateral sediment bars and point bars continue to shape the channel and vegetation develops on these bars. The floodplain connection is adequate to limit shear stress in this reach.

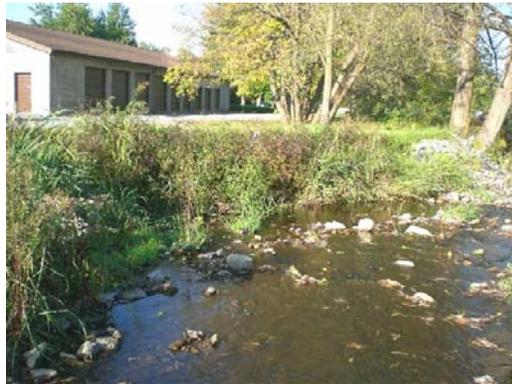
The lower middle reach of Densmore is 1,300 ft in length and has been altered during construction activity of storage units on the parcel adjacent to the left streambank. The downspouts for rooftop drainage are piped directly to the stream. This stream channel has been reshaped and the floodplain has been filled and raised to contain higher flows within the banks of the channel. The buffer has been eliminated and rip rap has been placed to try to armor the streambanks and protect against excess bank migration. It is evident that rip rap has been replaced as much of the formerly placed rip rap has been transported and deposited downstream. The deposited rip rap is producing a tailwater condition on the culvert that passes under East Lake Road. This reach has moderate sinuosity and bank material that is formed from alluvial deposits.

Photo 8- Floodplain filled and maintained

The lower middle reach will continue to be unstable until the channel and floodplain have reached a stable form. Bank migration will continue and large storms will transport the armoring rip rap down stream. When the rip rap is transported from the banks there will be severe bank erosion due to the lack of a riparian buffer. Currently the sediment supply on this reach is low dominated by bank erosion within the reach sediment supply. The water and sediment supply of the watershed will dictate the stable form of the stream channel.

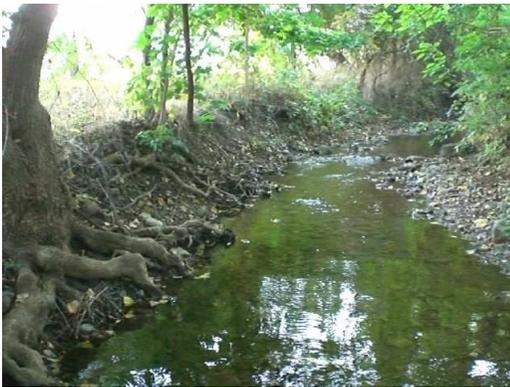
The lower reach of Densmore is 900 ft in length and has been straightened until it enters into Conesus Lake. The lower reach has historically been modified to encourage drainage and reduce flooding. Concrete and rip rap are being used to prevent the channel from meandering and eroding the streambanks. The right bank has a retaining wall to protect the bank from erosion and protect property. The concrete retaining wall allows for floodplain interaction while the channel is fairly wide to encourage bar formation within the hardened banks of the channel. Due to the channel dimension relative to the concrete wall, excess scour on the streambed has not been observed.

Photo 9 – Wide channel with bar formation

In the lower reach of Densmore the channel is straightened and levied, but the channel still has access to a floodplain for large flows. The channel is also wide enough to spread out the flow and limit the shear stress that causes erosion. This reach will continue to build lateral sediment bars.

There should also be a minimum of a 25ft buffer planted on both banks of the channel. The existing levees should be repaired as setback levees to allow for overbank flooding.

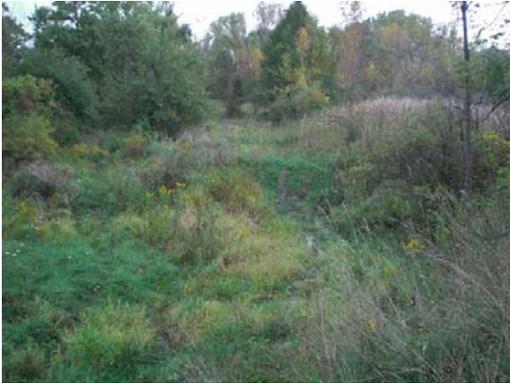
The upper reach of Central Creek is a low gradient wetland system with a low flow pilot channel. The banks are well vegetated and stable. There is very good connection to the floodplain and as a result there is low shear stress. There is very little bank erosion on this reach. This reach is approximately 1000ft in length and has areas of little to no buffer. The land use of this reach was formerly intensive agriculture with a lack of soil conservation practices. This reach is currently fallow and out of production.

Photo 1 – Wetland with low flow channel

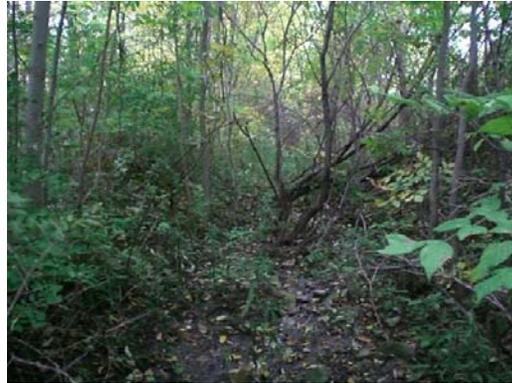
Photo 2 – Vegetation & floodplain connection

The upper reach of Central Creek will become more stable as the buffer is maintained and soil conservation practices are employed for future agriculture. This reach has dense vegetation and the banks that had been impacted by hoof shear from cattle are now rebuilding and recovering.

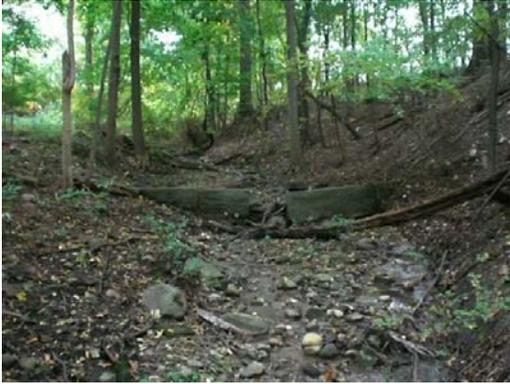
The middle reach of Central Creek is approximately 1,100ft. This reach of stream has a sediment dam step pool profile. In much of the valley the sediment dam is formed on an outcrop of bedrock by logs and boulders getting trapped behind the bedrock pinch point in the valley. These alternating debris fans have shale deposits as well as legacy sediments embedded into the deposited materials. These legacy sediments have been transported from the upland areas during intensive agricultural and tilling periods. This reach is the steepest reach of this segment of stream. There is active erosion of banks and shale outcrops. There are currently many sediment and debris dams that accelerate local instability. There is a 100ft or greater buffer on both banks of this reach. Sediment deposition and mass wasting of the banks results in localized contraction of low flows and high shear forces. There is a broad floodplain in this reach. The stream is slightly incised but still accesses the historic floodplain during high stormflow.

Photo 3 – Concrete weir and sediment dam

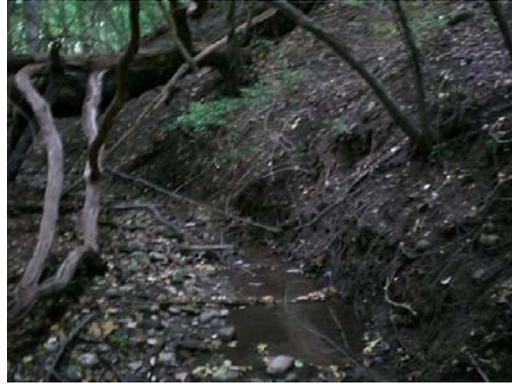
Photo 4 –Bank erosion valley wall

The middle reach of Central Creek has moderate sediment loading. The debris and log jam profile of this reach will begin to migrate sediments downstream as the dams break down and reform at lower elevations in the valley. This reach has a moderate connection to a broad floodplain valley and high storm flows are able to flow over the floodplain and dissipate energy. There will continue to be quantities of mass wasting from banks and terraces where the channel flows at the valley toe. Shale valley walls and terraces that confine the left streambank will continue to shear and shale deposits will be transported downstream. The current water and sediment supply of the watershed will dictate the stable form of the stream channel.

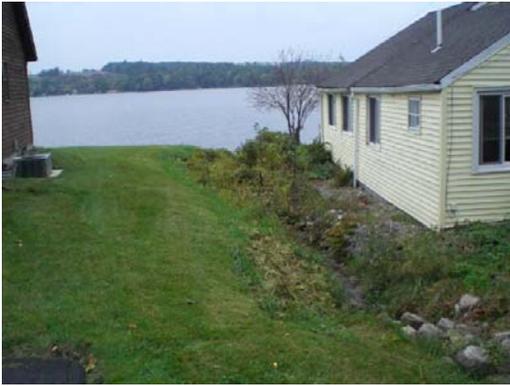
The lower reach of Central Creek is 600 ft in length and is straightened until it enters into Conesus Lake. The lower reach has historically been modified to encourage drainage and reduce flooding. Rip rap has been used to prevent the channel from meandering and eroding the streambanks. There is a dwelling on the right bank and no riparian buffer.

Photo 5 – Rip rap and low right bank

The lower reach of Central Creel will continue to degrade and there will be bank erosion and possible bank migration on the right bank. The bank migration rate will be limited since the reach is flat. The foundation of the residential dwelling on the right bank is currently at risk of being undermined. The left bank is higher than the right bank and directs flooding to the right overbank area.

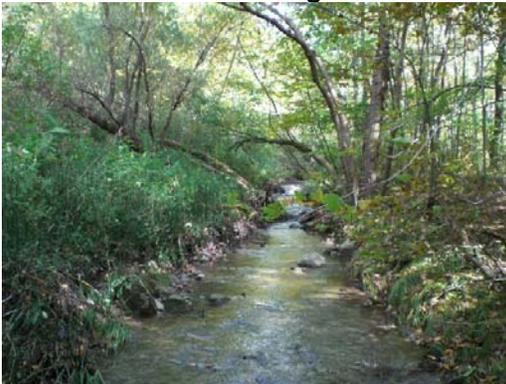
Photo 1 – Stable with vegetated bench

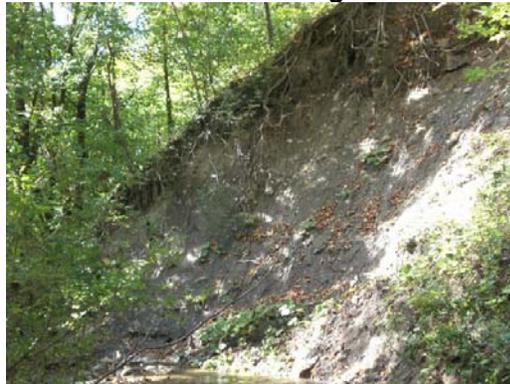
Photo 2 - Unstable eroding terrace

The upper reach of North Gully will continue to be a significant sediment source from the mass wasting and bank erosion of high terraces that confine the stream laterally. The upper reach of North Gully will continue to erode the existing valley and create a new floodplain that will transport sediment downstream until the shear forces of the stream are not in direct contact with the terraces.

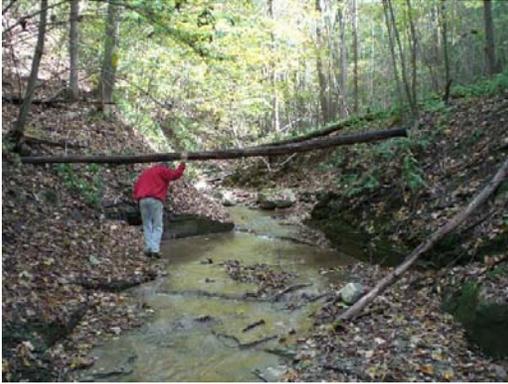
Photo 1 - Confined shale bedrock

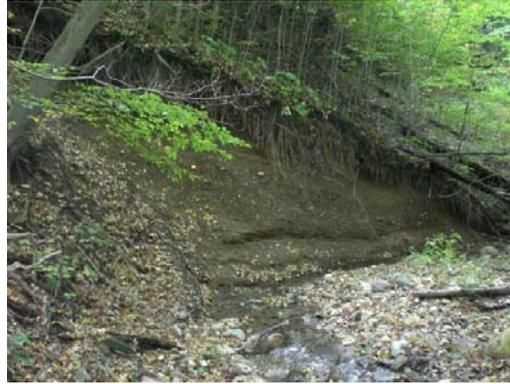
Photo 2 - Unstable eroding terrace

The upper reach of South Gully will continue to be unstable and experience a large amount of bank erosion until a new floodplain is formed in the existing valley. To allow the upper reach of South Gully to erode enough to create a new floodplain would result in a massive transport of sediment downstream.

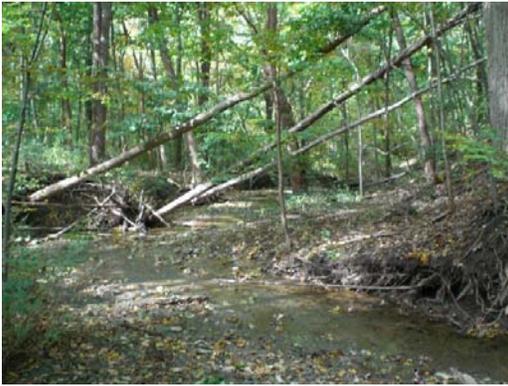
The middle reach of South Gully has a broad historic floodplain terrace. This incised reach displays a very sinuous channel that has significantly down cut from the historic elevation and has departed from the floodplain. The reach has had considerable bank migration and channel evolutions. Twenty-foot high glacial terraces confine the bank migration and erosion, these terraces have led to an especially high sediment supply. Large downed trees and glacially transported cobble and boulder are exposed and form debris and sediment jams in the lower energy segments of this reach. There is localized contraction of flow and large energy drops over these in-stream debris jams that then cause bank erosion near the debris jam structures. The lower section of the middle reach of South Gully has one landowner who is experiencing land loss of his yard and the loss of large trees due to bank erosion and bank lateral migration.

Photo 7 - Channel migration & bank erosion **Photo 4 - Property loss residential yard**

The middle reach will continue to be laterally unstable until the floodplain has reached a stable form. The water and sediment supply of the watershed will dictate the stable form of the stream channel. The current bank migration, bank erosion and chute cut offs will continue to add to the sediment supply of this reach.

The middle reach of South Gully has significant bank erosion resulting in a high sediment load. It is recommended that the middle reach and the related floodplain be re-graded and the banks be stabilized to deal with the current watershed. The stabilization and re-grading of this reach will enable the stream to transport the sediment supplied from upstream without contributing additional sediment to the system. The relocation and regrading of the channel will also allow for the reduction of erosional forces that are contributing to the property loss at the lower section of the middle reach of South Gully.

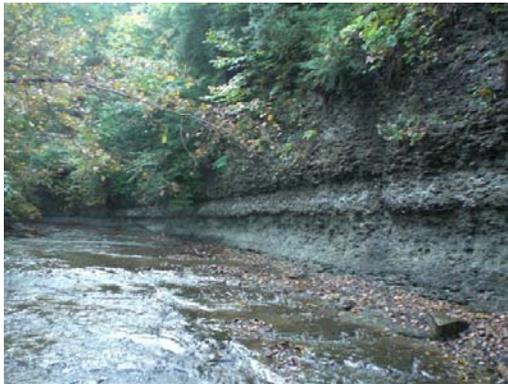
The upper reach of North McMillan starts approximately 1,400 ft east of East Lake Road and is approximately 1,700 ft in length. Approximately 1,400 ft from East Lake Road there is a 100ft high valley wall that is actively eroding. During large storm events there is high sediment loading from the cut valley wall with shale deposits shearing from the bank. This reach has downcut and struck shale and bedrock vertical confinement. Although the invert of the stream has hit bedrock in some locations there are significant amounts of bank erosion due to excess forces during large storm events. There are two cut terraces that contribute the majority of the sediment from this reach. There is a 50-100 ft buffer on the left bank of this reach and a 0-25ft buffer on the right bank. There are signs of levees and dredging on both the right and left banks. The stream reach downstream from the cut valley wall is an over widened channel with one mid-channel bar and lateral bar formation from the supplied sediment upstream.

Photo 1 – Unstable eroding valley wall

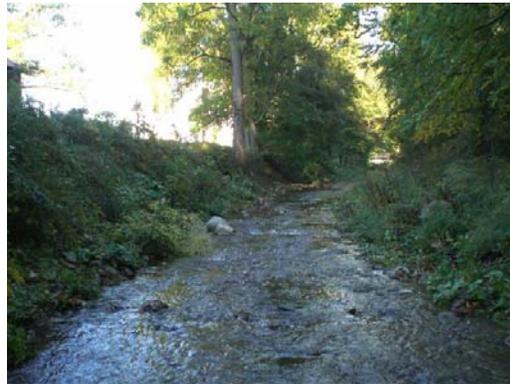
Photo 2 - Unstable over-wide channel

The upper reach of North McMillan Creek has moderate sediment loading. The over widened channel depends on the sediment supply to support formation of lateral bars that will eventually become a lower confined floodplain. The current state of channel evolution depends on a high sediment source for recovery. The mid-channel bar in this reach will transition to a lateral bar with the replenishment of sediment. There will continue to be bank erosion if the stream buffers remain narrow or non-existent. As a floodplain forms and the lateral bank expands, flows will be concentrated on the channel side. Concentration of flow, causing near bank stress, will erode the streambanks. To allow the upper reach of North McMillan to deposit sediment and form a new floodplain in the existing valley would be a fairly low probability of recovery, assuming levees and dredging was maintained or continued.

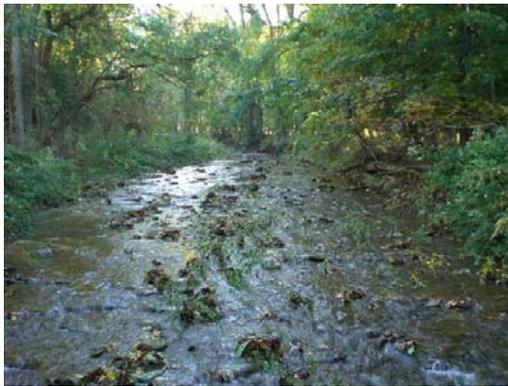
The middle reach of North McMillan is west of East Lake Road. This reach has a broad historic floodplain terrace. This reach is approximately 2,000ft of high sinuous moderately incised channel that is no longer connected to the historic floodplain. With the sediment supply, current vegetation, and the existing sinuosity, the channel is unstable. This reach has significant bank migration, chute cut offs, traverse bars and channel evolutions. The bank erosion resulting from the current instability is causing large trees to fall into the streambank. There is a landowner who is experiencing structural foundation undermining, land loss and loss of large trees. There is a 100-200 ft buffer on the left bank of this reach and a 0-50ft buffer on the right bank.

Photo 3 - Unstable over-wide channel

The middle reach of North McMillan has significant bank erosion and that dominates the sediment load. It is recommended that the middle reach be relocated, the related floodplain be re-graded, and the banks be stabilized to deal with current watershed conditions. The 2,000 ft relocation/restoration will utilize **log vanes** and **rock vanes** to stabilize and hold grade for the relocated channel. **Rock vanes** will be used to divert flows from foundations. **Brush mattresses** and cutting a **bankfull bench** will provide bank stability and reduce the near bank stress. (Specifications and details for bold/italicized items can be found in the Appendix).

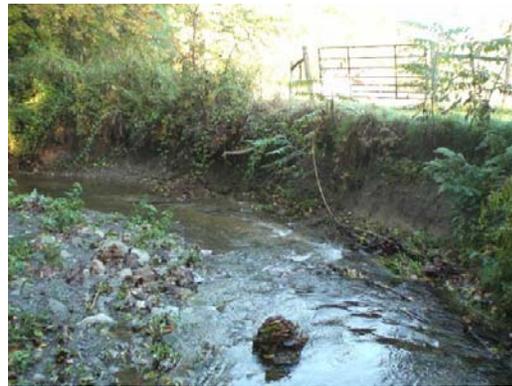
Photo 4 – Bank migration and erosion

The middle reach will continue to be laterally unstable until the floodplain has reached a stable form. Currently the sediment supply on this reach is dominated by sediment from bank erosion. The bank erosion, channel migration and lack of buffer will lead to a chute cut off and significant channel evolutions. The water and sediment supply of the watershed will dictate the stable form of the stream channel.

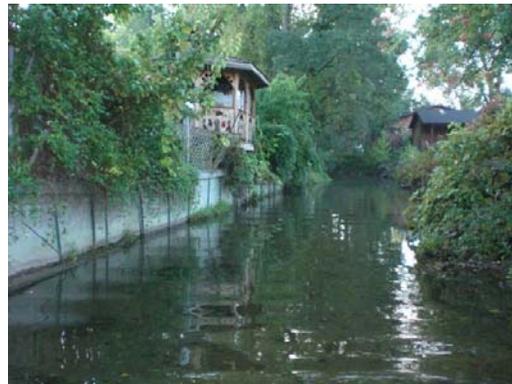
The lower reach of North McMillan Creek is 1,000 feet of straightened channel to the confluence with Conesus Lake. The lower reach has historically been modified to encourage drainage and reduce flooding. Both banks have retaining walls and large boulders to protect the banks from erosion and protect structural foundations. The right bank of this reach is within 30 ft of causing severe structural foundation damage. The last 500 ft of the stream is under backwater influence.

Photo 6- Right bank retaining wall

The lower reach of North McMillan will continue to cut away at both banks in the upper 500ft of the free flowing section of this reach. The channel will continue to deposit sediment and redirect flows with a result of channel meandering. The natural stable form and pattern of North McMillan Creek would be a sinuous channel with a dimension of near 75 square ft. In the lower reach of North McMillan the channel is straightened and levied. The channel does not have access to a floodplain for relief from large flows, nor does it have a meandering pattern to dissipate excess energy. The result will be continued bank erosion as the channel carves a stable pattern and new floodplain. The foundation of the residential dwelling will be undermined and the land loss will continue until the left bank is stabilized. The right bank erosion and possible failure of retaining walls and structures will also progress. The levees assist in increasing the forces for sediment transport and bank erosion.

On the lower reach, flood protection and property protection are the primary goals. Relocation and restoration of dimension, pattern and profile is recommended for this reach. This will limit the risk to property by dealing with sediment supply and providing a

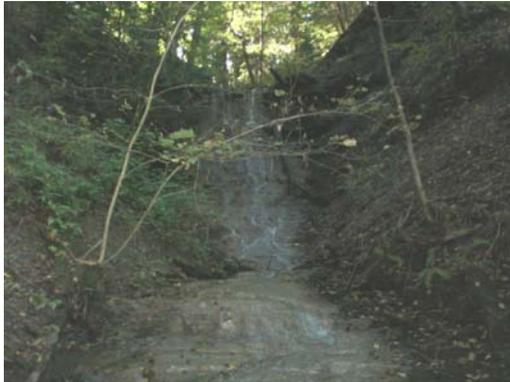
The upper reach of Southwest Creek is a very high gradient cascade and waterfall system that is vertically confined by bedrock. This reach is approximately 1,500ft in length. This reach is stable for the valley, there are small debris dams that form behind geologic formation but these are typical of high-energy systems like this reach. There is one major waterfall and several 5-15ft cascades and geologic formations.

Photo 1 – Waterfall ~80ft drop

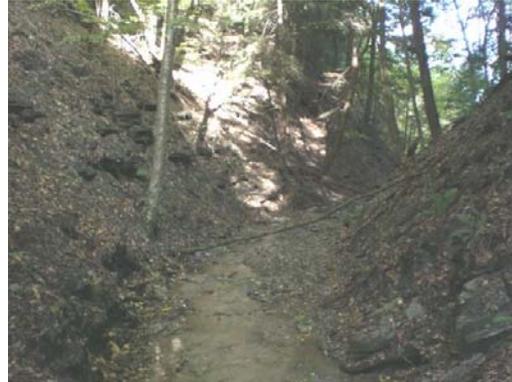
Photo 2 –Stable confined valley type

The upper reach of Southwest Creek will remain stable as long as the buffers are maintained.

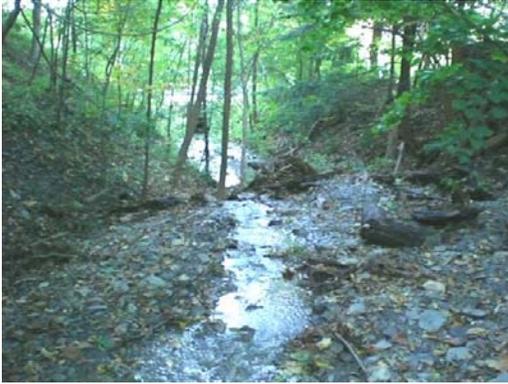
The lower reach of Southwest Creek is 1,000 ft in length and characterized by sediment debris dams and an over wide channel. The lower reach has historically been levied on the right bank to encourage drainage and reduce flooding. This reach starts at the beginning of a valley change. The valley goes from a severely confined valley to a moderately confined valley. The sediment deposits are dominated by shale.

Photo 3 – Over wide incised channel

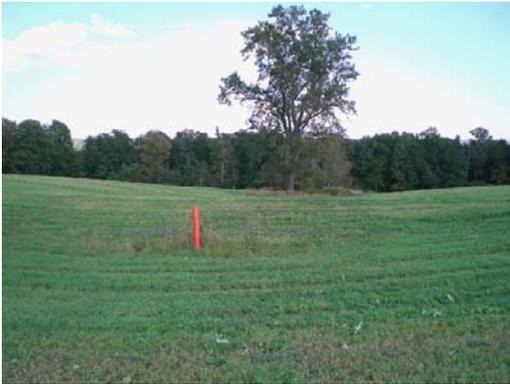
Photo 1 – Catchment basin and standpipe

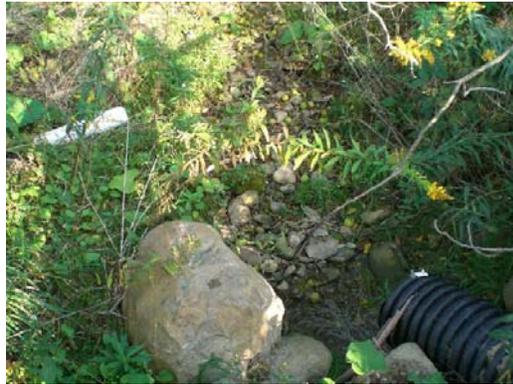
Photo 2 –Tile drain outfall to the rivulet

The upper reach of Groveland Rivulet will remain stable as long as the buffer is maintained and soil conservation practices are employed for agriculture. The increased drainage from the tile drains will produce a localized scour and erosion near the drain outlets but this scour will be local.

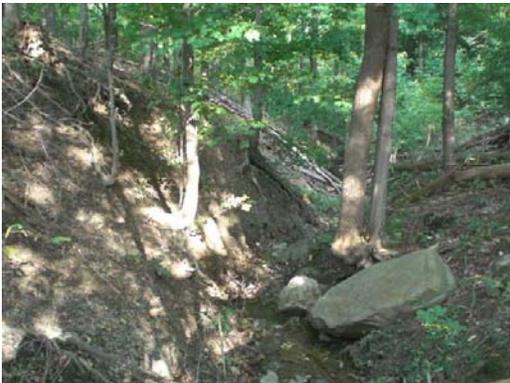
Photo 3 – Confined Valley

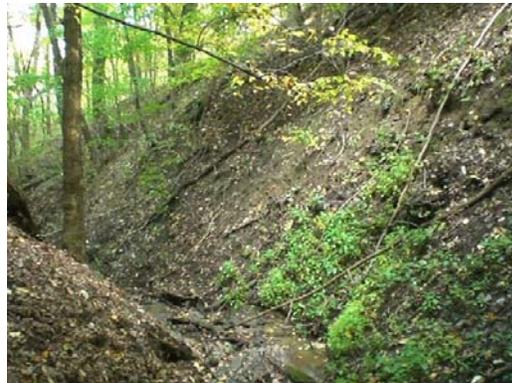
Photo 4 –Bank erosion

The upper middle reach of Groveland Rivulet has high sediment loading. The debris and log jam profile of this reach will continue until bedrock confinement is reached or the sediment from upstream is deposited on the downstream sediment fans to hold grade. The latter will occur once the upstream section has eroded enough material to carve a floodplain at a lower elevation. There will continue to be large quantities of mass wasting of banks and terraces. Shale valley walls that confine the stream will continue to shear and shale deposits will be transported downstream.

There should be minimal actions taken in the upper middle reach as much of this reach is confined by bedrock and shale. Some selected shale outcrops that are confining the stream should be removed. It is recommended that unstable sediment dams be removed and re-graded as needed. It will be more efficient to deal with the sediment source on the downstream reaches. The buffer in the watershed should be planted and maintained. There should be a buffer around significant tributaries in the watershed.

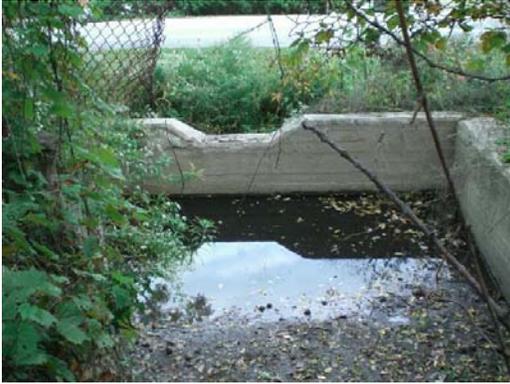
Photo 7 – Sediment trap

The lower reach of Groveland Rivulet is piped and the sediment trap will eventually fill and need to be maintained.

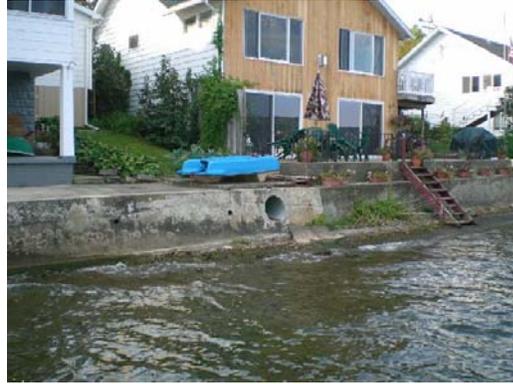
Photo 8- Outfall of the Groveland Rivulet

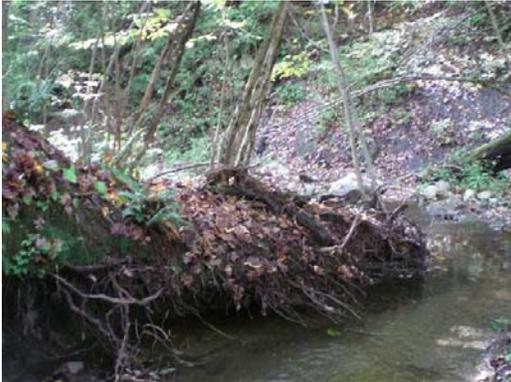
Photo 1 – Unstable eroding streambanks

The upper reach of Long Point has high sediment loading. The debris and log jam profile of this reach will continue until bedrock confinement is reached or sediment from upstream is deposited on downstream sediment fans to hold grade. The latter will occur once the upstream section has eroded enough material to carve a floodplain at a lower elevation. There will continue to be large quantities of mass wasting of banks and terraces.

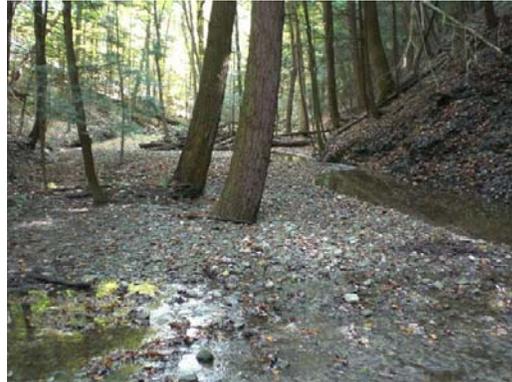
Photo 2 – Sediment and debris fan

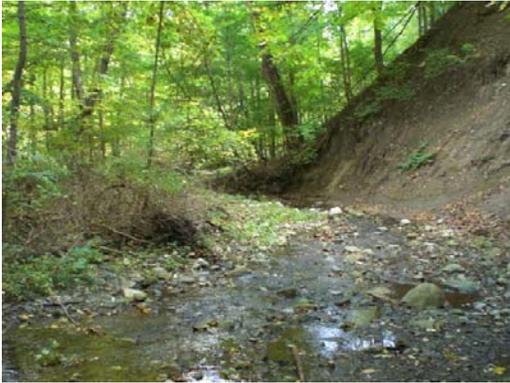
Photo 3 – Bank erosion cut terrace

The middle reach will continue to be laterally unstable until the floodplain has reached a stable form. The middle reach is serving as a sediment sink as the valley opens and deposition occurs on the bars and benches to fill in the over wide channel. Currently the sediment supply on this reach is dominated by upstream sediment. The water and sediment supply of the watershed will dictate the stable form of the stream channel.

The middle reach of Long Point has bank erosion but is currently aggrading. Relocation and restoration of 1,100 ft of stream, changing the dimension, pattern and profile to deal with current watershed sediment supply, is recommended.

Log vanes and **rock vanes** will be used in the relocated channel to stabilize and hold grade in the new channel. **Brush mattresses** and a **bankfull bench** will be utilized to stabilize banks and reduce stress on the channel sides. (Specifications and details for bold/italicized items can be found in the Appendix).

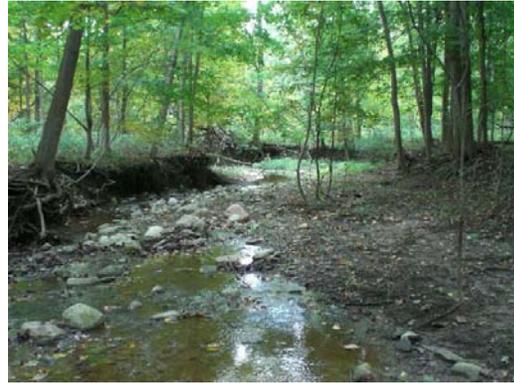
Photo 4 – Bank erosion and floodplain

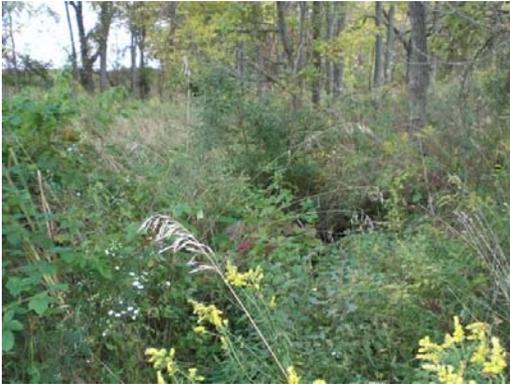
Photo 1 – Wetland with low flow channel

The upper reach of Sand Point will remain stable as long as the buffer is maintained and soil conservation practices are employed for agriculture.

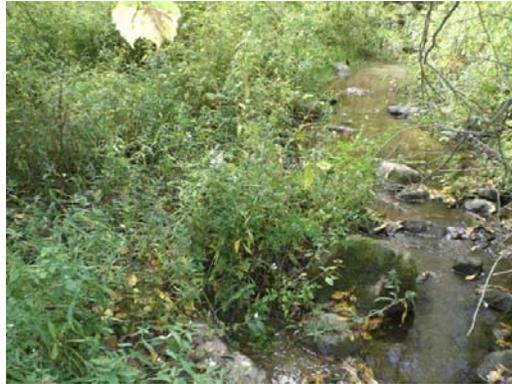
Photo 2 –vegetation & floodplain connection

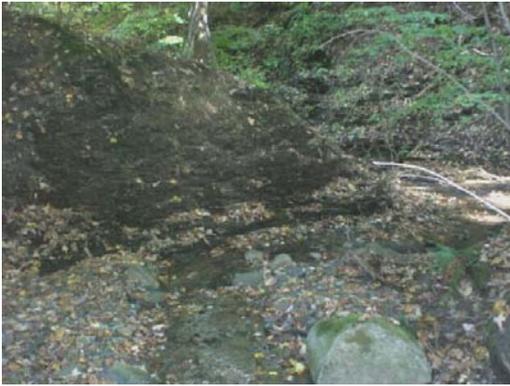
Photo 3 – Eroding shale banks

The upper middle reach of Sand Point has high sediment loading. The debris and log jam profile of this reach will continue until bedrock confinement is reached or the sediment from upstream is deposited on downstream sediment fans to hold grade. The latter will occur once the upstream section has eroded enough material to carve a floodplain at a lower elevation. There will continue to be large quantities of mass wasting of banks and terraces. Shale valley walls that confine the stream will continue to shear and shale deposits will be transported downstream.

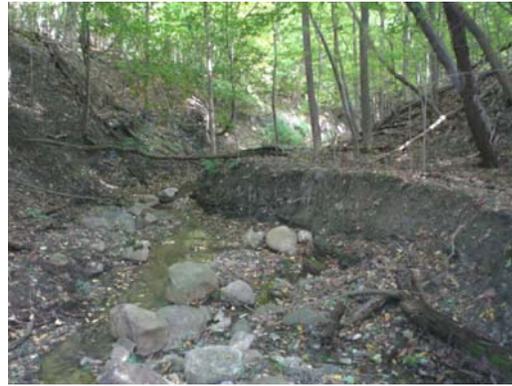
Photo 4 – Headcut – former sediment dam

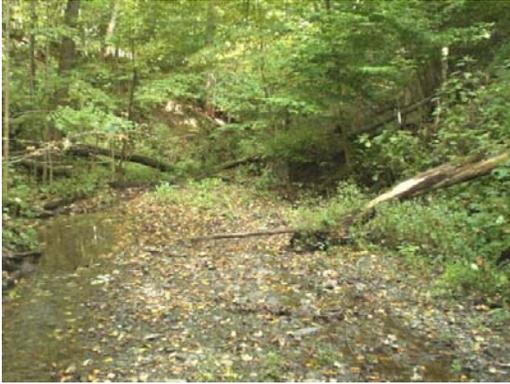
Photo 5 – Sediment and debris deposition

The lower middle reach will continue to be unstable until the floodplain has reached a stable form. The lower middle reach is serving as sediment sink with deposition occurring on the bars and benches to fill in the over wide channel. Currently the sediment supply on this reach is dominated by upstream sediment. The water and sediment supply of the watershed will dictate the stable form of the stream channel.

The middle reach of Sand Point Creek has minimal bank erosion and is currently aggrading. Transported sediments from upstream dominate the sediment load of this reach. It is recommended that unstable sediment dams be removed and re-graded as needed. Artificial sediment dams can be constructed that allow for a preferential low flow channel. ***Rock cross vanes*** may be required to stabilize and provide grade control to the newly formed channel. (Specifications and details for bold/italicized items can be found in the Appendix).

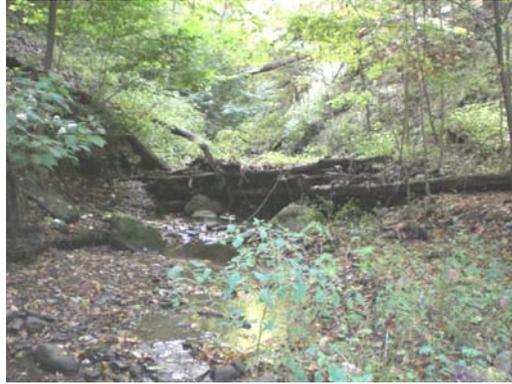
Photo 6 – Sediment and debris dam

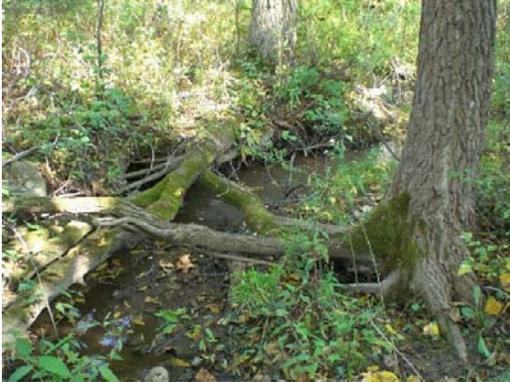
Photo 3 – Wetland with low flow channel

The upper reach of Eagle Point Creek will remain stable as long as the buffer is maintained and soil conservation practices are employed for agriculture.

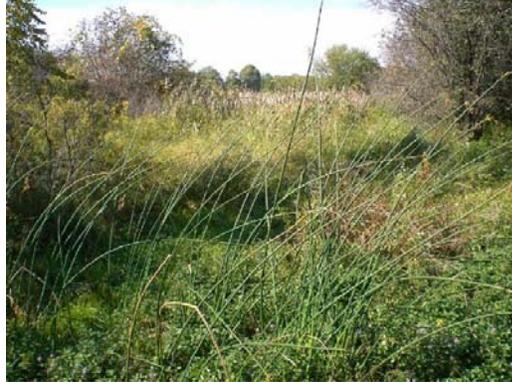
Photo 4 – Vegetation & floodplain connection

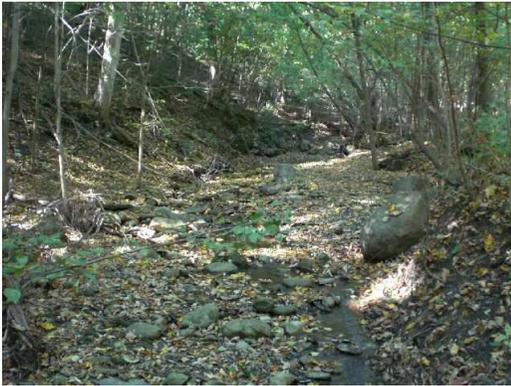
Photo 3 – Sediment debris fan

The upper middle reach of Eagle Point Creek has high sediment loading. The debris and log jam profile of this reach will continue until bedrock confinement is reached or the sediment from upstream is deposited on downstream sediment fans to hold grade. The latter will occur once the upstream section has eroded enough material to carve a floodplain at a lower elevation. There will continue to be large quantities of mass wasting of banks and terraces. Shale valley walls that confine the stream will continue to shear and shale deposits will be transported downstream.

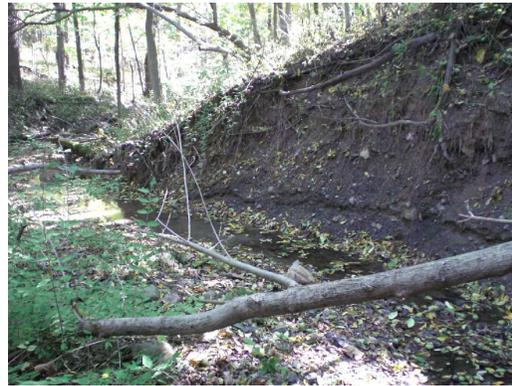
Photo 4 –Bank erosion valley wall

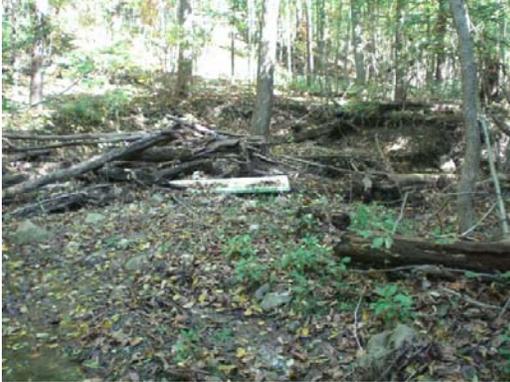
Photo 5 – Sediment and debris deposition

The lower middle reach will continue to be unstable until the floodplain has reached a stable form. The lower middle reach is serving as a sediment sink with deposition occurring on the bars and benches to fill in the over wide channel. Currently the sediment supply on this reach is dominated by upstream sediment supply. The water and sediment supply of the watershed will dictate the stable form of the stream channel.

The lower middle reach of Eagle Point has minimal bank erosion and is currently aggrading. Transported sediments from upstream dominate the sediment load of this reach. It is recommended that unstable sediment dams be removed and re-graded as needed. Artificial sediment dams can be constructed that allow for a preferential low flow channel. ***Rock cross vanes*** may be required to stabilize and provide grade control to the newly formed channel. (Specifications and details for bold/italicized items can be found in the Appendix).

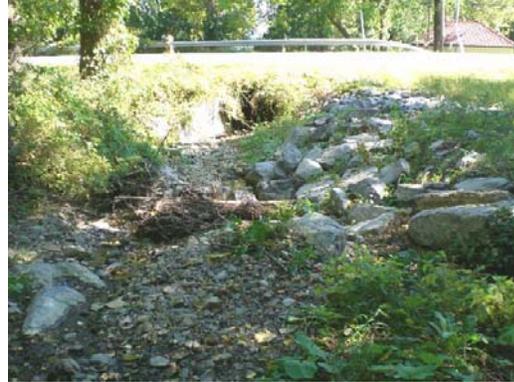
Photo 6 – Culvert under West Lake Road

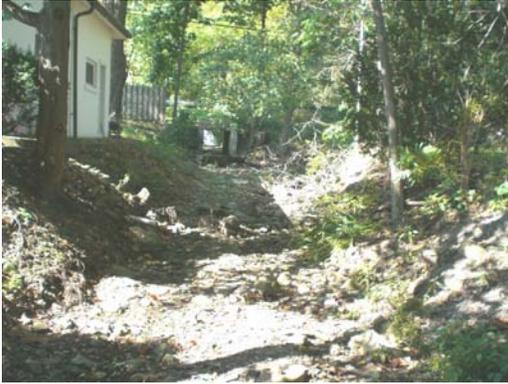
Photo 7 – Unstable over wide channel

The lower reach of Eagle Point will continue to aggrade in the upper, free flowing section of this reach. The channel will continue to meander. The natural stable form and pattern of Eagle Point Creek would be a sinuous channel with a dimension of nearly 30 ft². In the lower reach of Eagle Point the channel is straightened and levied, resulting in the channel not having access to a floodplain for large flows. The foundations of the residential dwellings are not currently at risk of being undermined while this reach continues to be in a state of aggradation. There are three stream crossing and culverts on this section that hold grade and back up water during high flows.

While the lower reach is oversized and aggrading it is not currently increasing sediment loading downstream. There is also very minimal bank erosion on this reach. At this point the only recommendation for bank stabilization is to increase the width of the riparian buffer to 25ft.
